LESSONS LEARNED FROM HYDROGEN ACCIDENTS

(EVENTS REPORTED IN THE IN EAST CONTINENTAL ASIA)

Bin Wang^a, Pietro Moretto^b, Georg Mair^a, Teresa Orellana Pérez^a

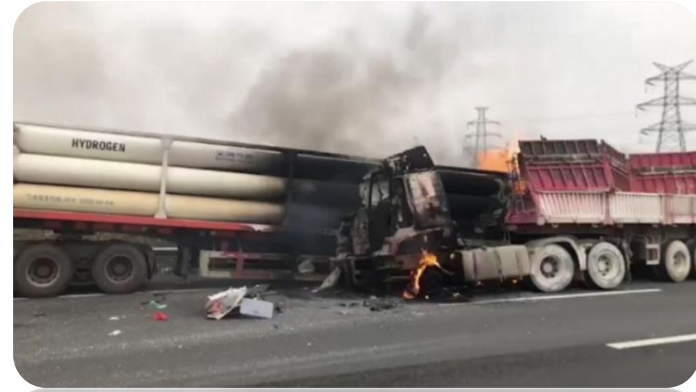
A trailer **containing 300kg of hydrogen** was rear-ended which started a fire.

The hydrogen tank was ruptured due to the impact on the rear of the tank, which caused a fire and quickly ignited. After about one hour of supervision and disposal, the hydrogen tanker was no longer in danger of explosion.

Casualties: driver injured

The explosion can be prevented by cooling down the temperature using water.

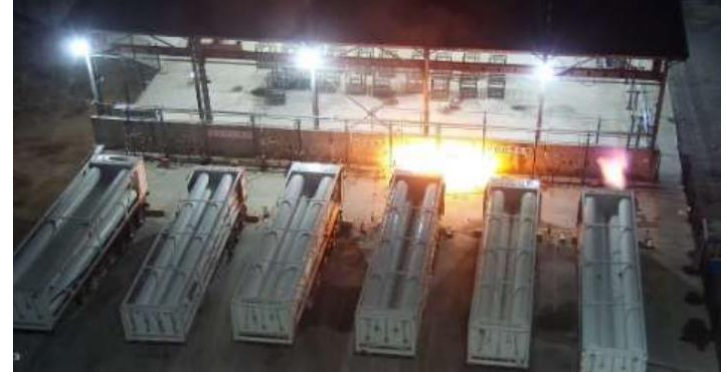
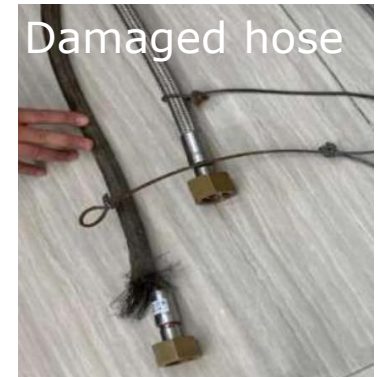
Main processes: during hydrogen refuelling up to 7.5MPa, H2 leak due to rupture of the hose. After 5 minutes, the leaking hydrogen started to burn: rupture hose **hits object and causing a spark to ignite the leaked hydrogen gas**, after 13 mins firefighters start spraying water on and around the fire to cool it down, after one hour, the fire stopped.

Casualties: no people injured.

Lessons learned: not using poor quality products

Delayed ignition, quick response needed.
H2 sensor can detect leaks.

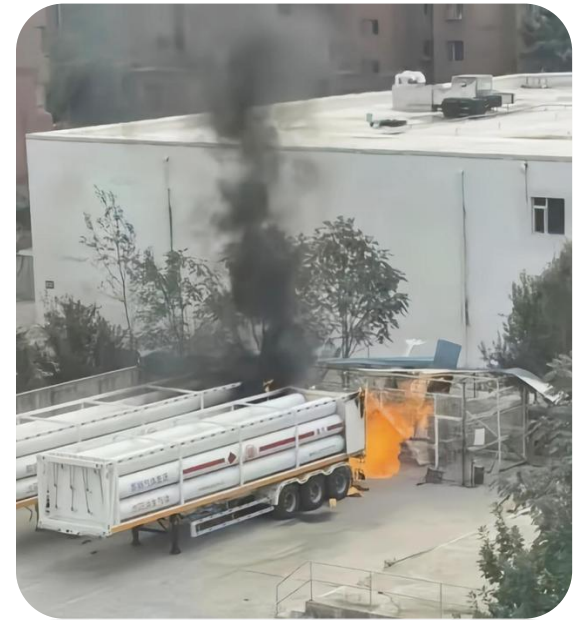
Filling hose ruptured due to poor design and bursted into flame, causing the tyres to burn and produce thick, black smoke. Ignition source is not clear but the fire was effectively controlled.

Cause: Filling hose ruptures (poor design)

Casualties: none

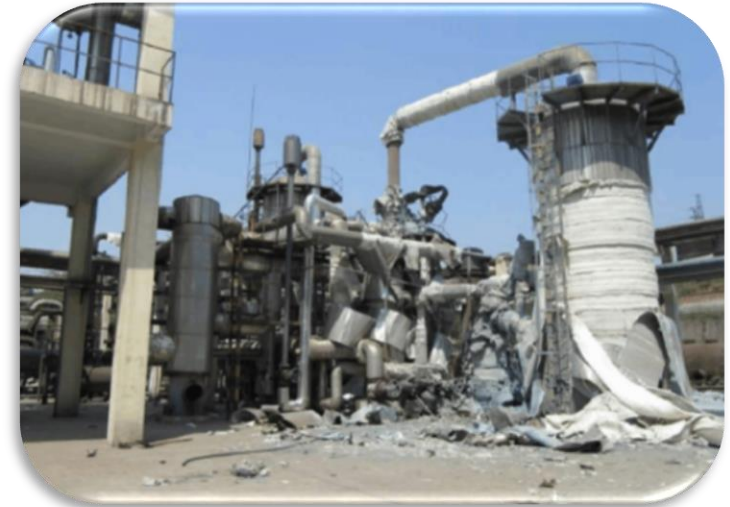
The methanation furnace in the gas workshop of a Biochemical company. (corrosion crack at welding area).

Cause: The welded joints of the outlet pipes were operating for a long time in the high temperature hydrogen containing gases. The defect was initiated and quickly developed. Hydrogen leakage occurred, and without safety measures, plugging and repair was carried out against the rules, therefore generating sparks and causing the explosion of the gas pipes.

Casualties: 4 people died, 2 people were injured.

Delayed ignition.
How to stop ignition safely?

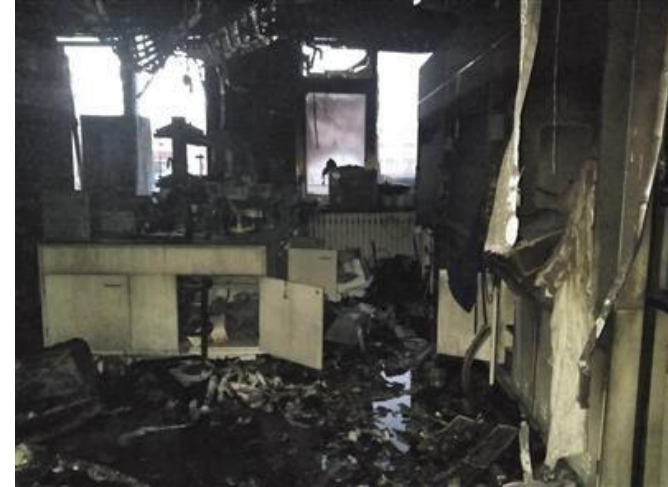
Main processes: the hazardous chemical substance tert-Butyllithium stored in the incident laboratory started burning, causing the hydrogen pressure cylinder stored in the laboratory to explode in the fire.

Cause: pressure vessel explosion caused by burning of chemical substance.

Casualties: instant death of a post-doc.
