A study of decrease burst strength on Compressed-hydrogen containers by drop test

**Japan Automobile research Institute
E-mobility Research Division**

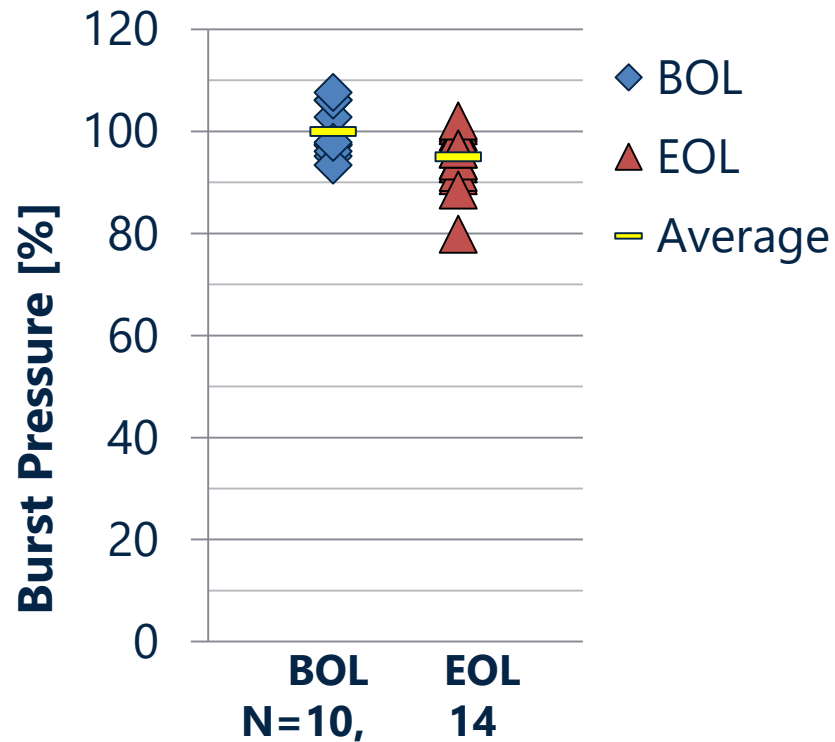
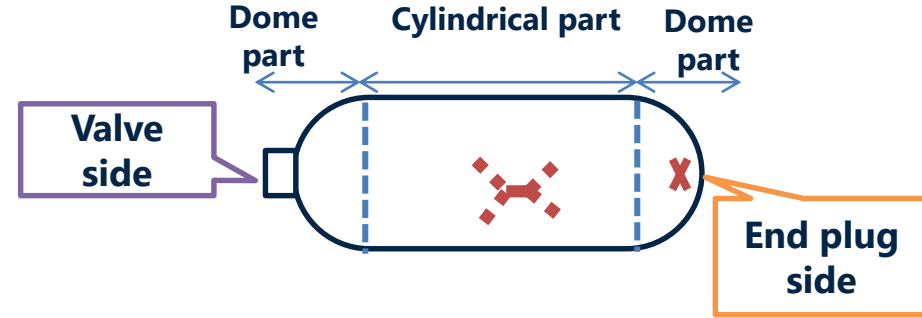
Rupture point

- The residual burst pressure at the End-of-Life decreased by about 5% from the initial burst pressure.
- The variations of the residual burst pressure at the End-of-Life were increased from the initial.
- **An impact site during vertical drop test may become the initial rupture point.**

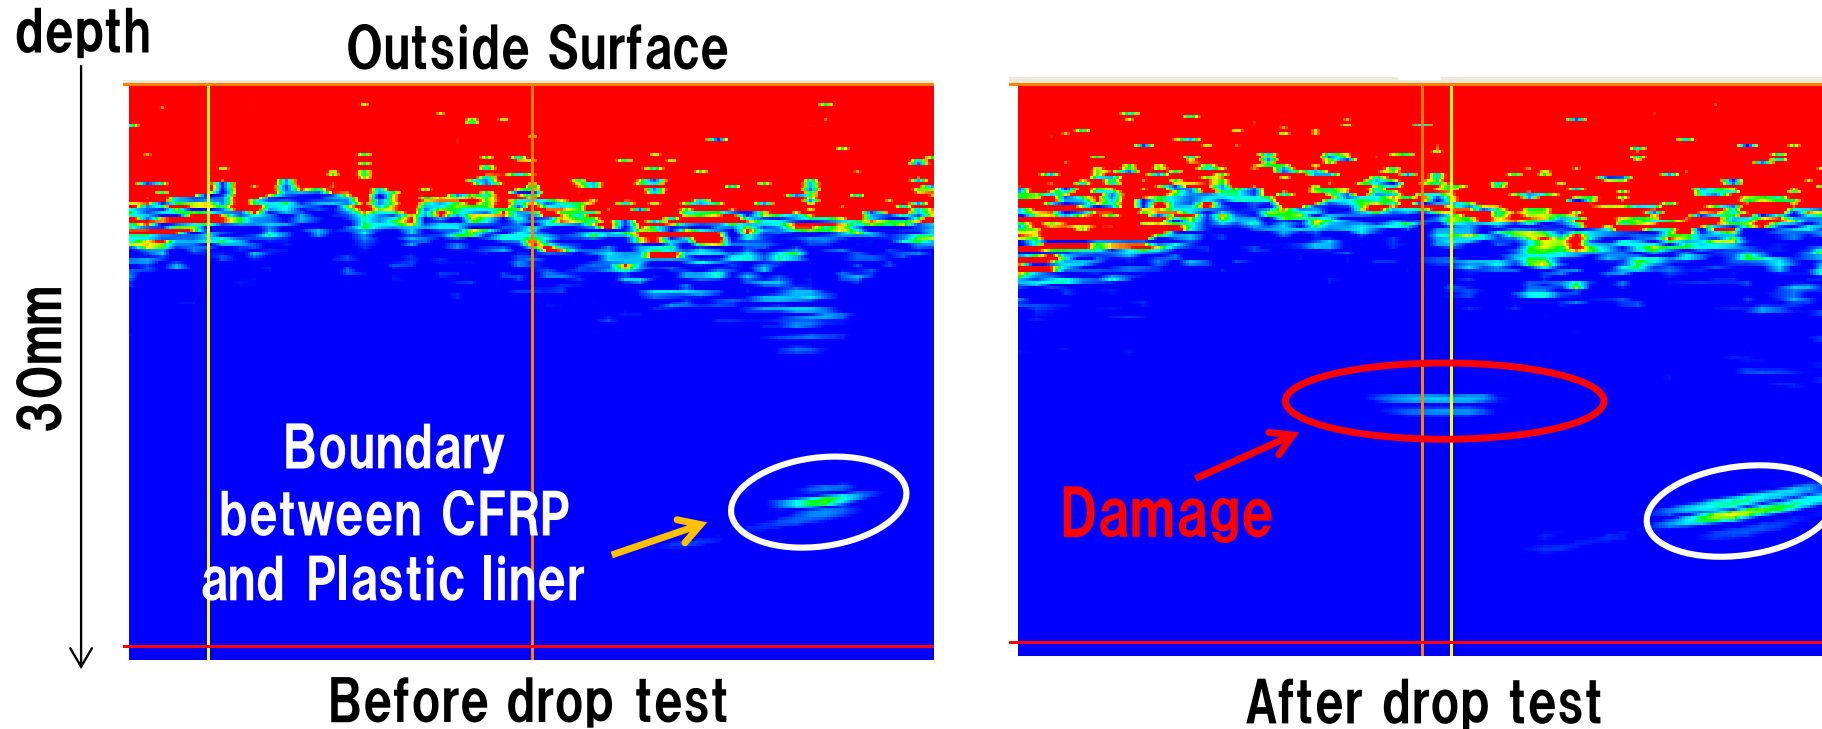
◆ Dome part

- ◆ Some reflection are observed at a depth of approximately 15 mm after the drop test and extends parallel to the CFRP surface

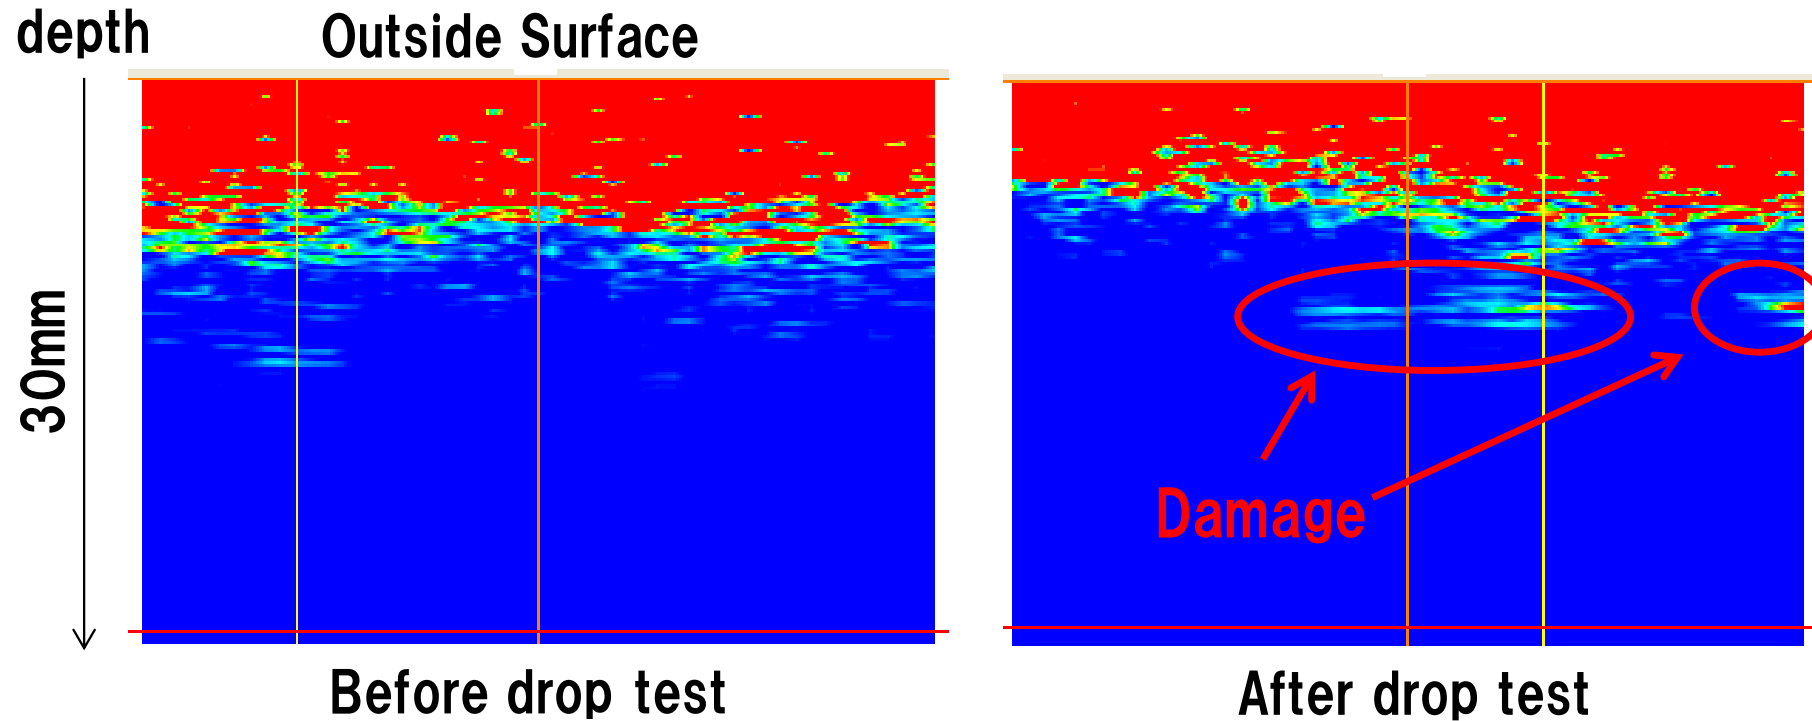
◆ Cylindrical part

- ◆ Some reflection are observed at a depth of approximately 10-15 mm after the drop test and extends parallel to the CFRP surface

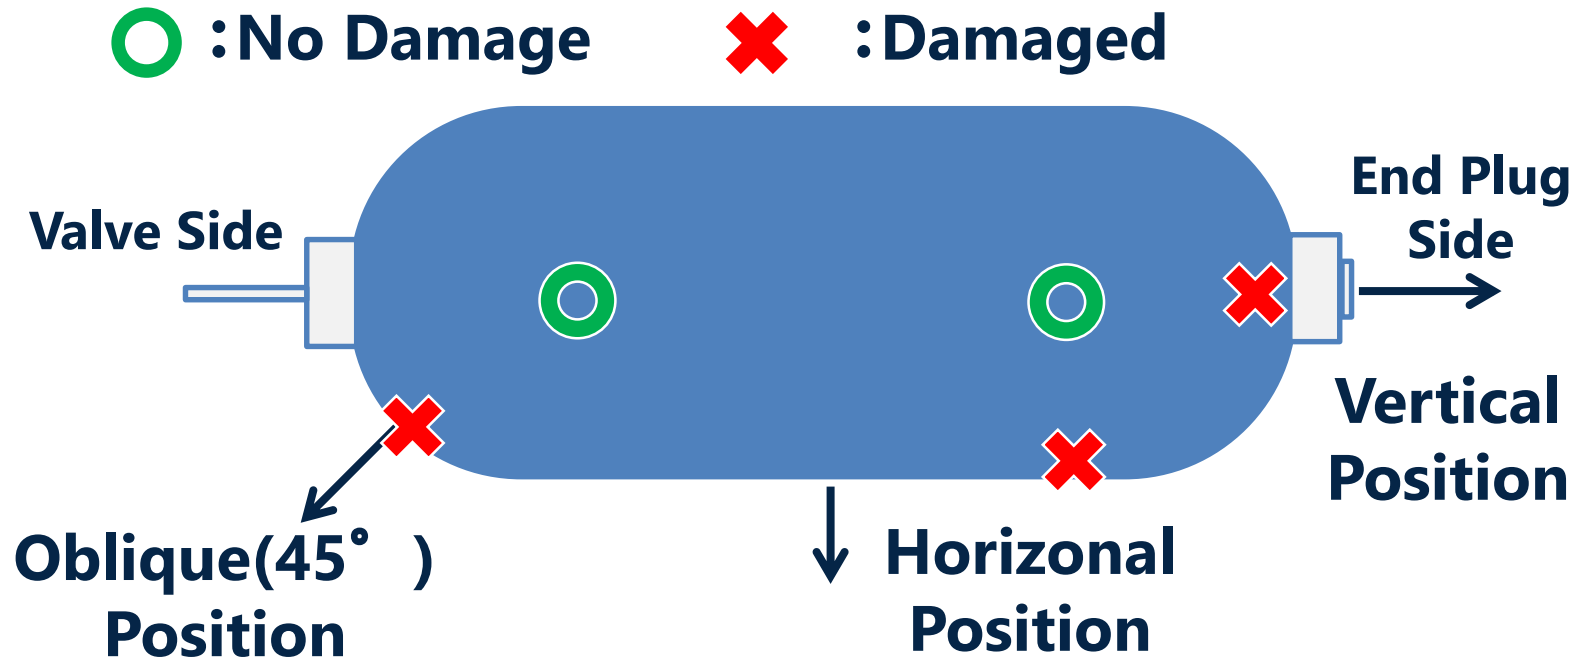
◆ Summary of the Ultrasonic flaw inspection result

- ◆ CFRP layer was damaged in all three directions (vertical, horizontal, and oblique directions) near the landing site.
- ◆ No damage was incurred away from the landing site of the drop tests

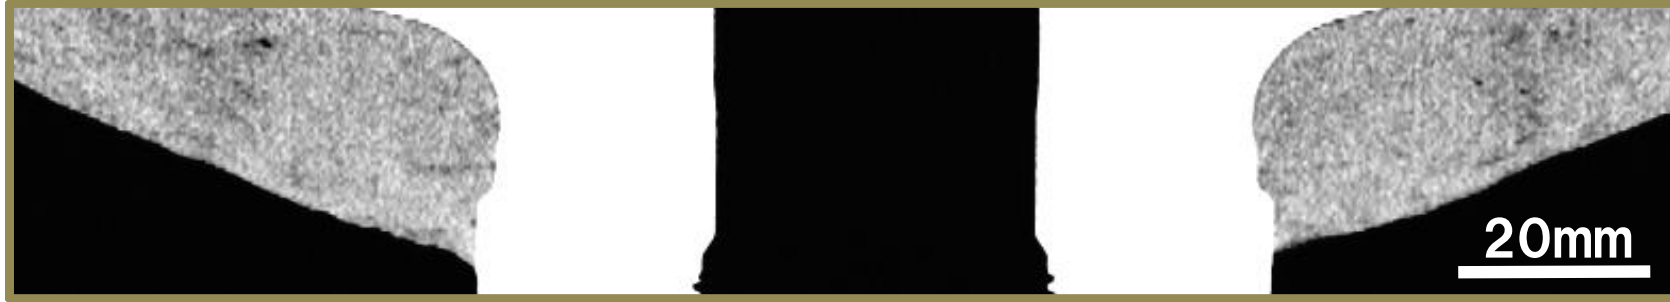
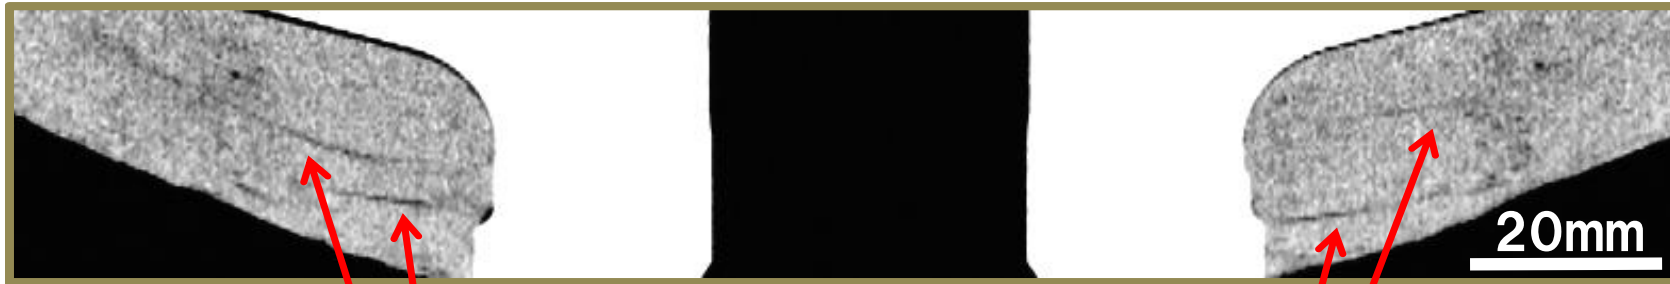
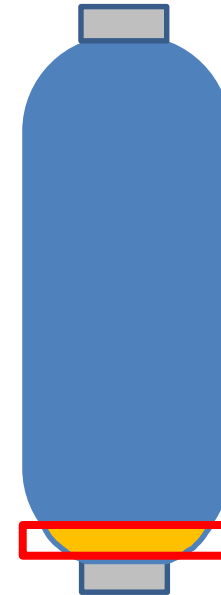
There were multiple **damages** in the middle of the CFRP layer near the boss on the plug side of the container after the drop test.

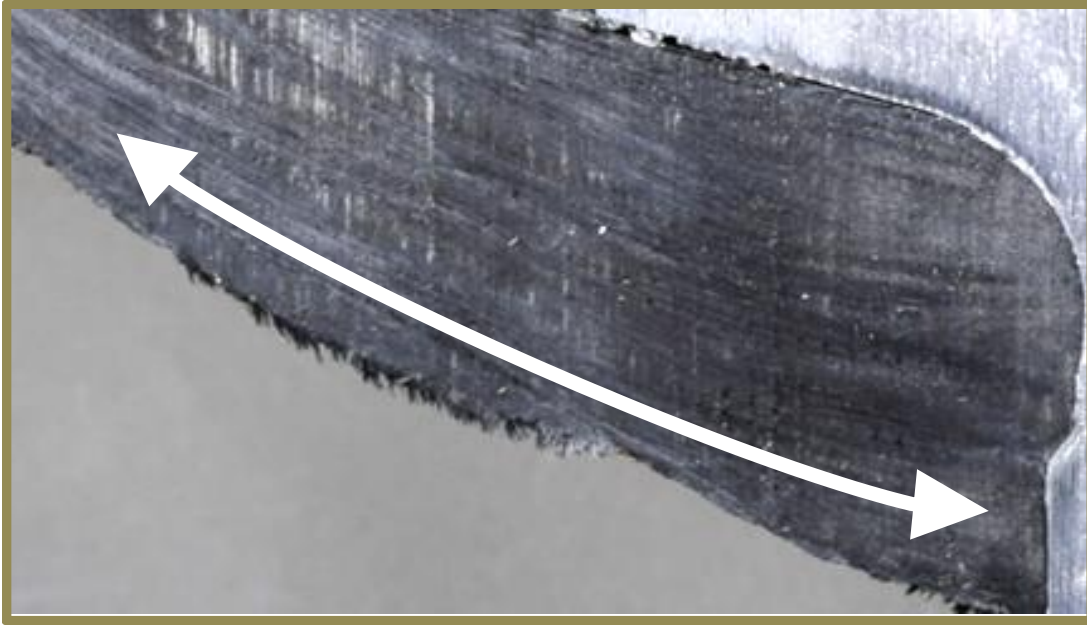
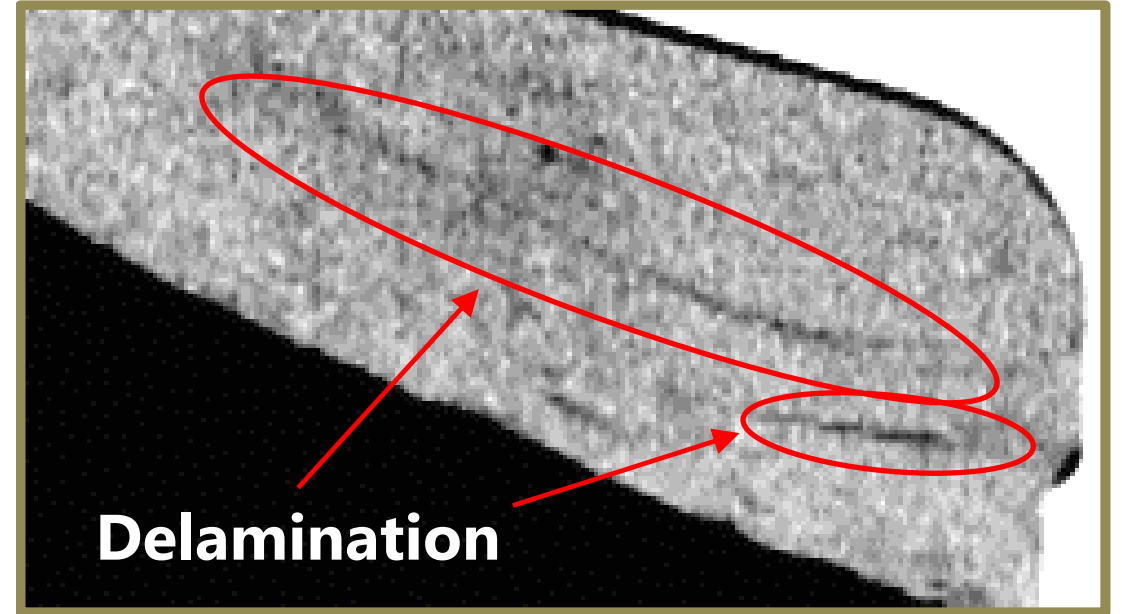
- ◆ One CFRP layer extends in the direction of the white arrow and forms the dome part by overlapping several layers.
- ◆ The damages are observed in the CFRP interlayer portion of the cross-section image.

The delamination occurs near the boss on the plug side by the drop test (vertical drop direction).

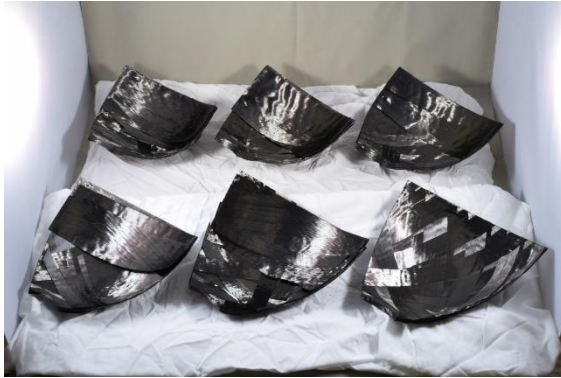
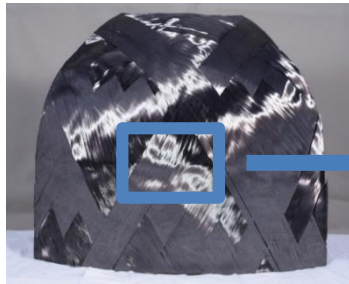
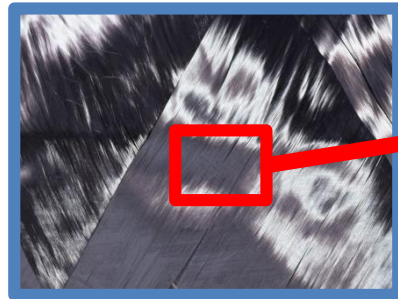
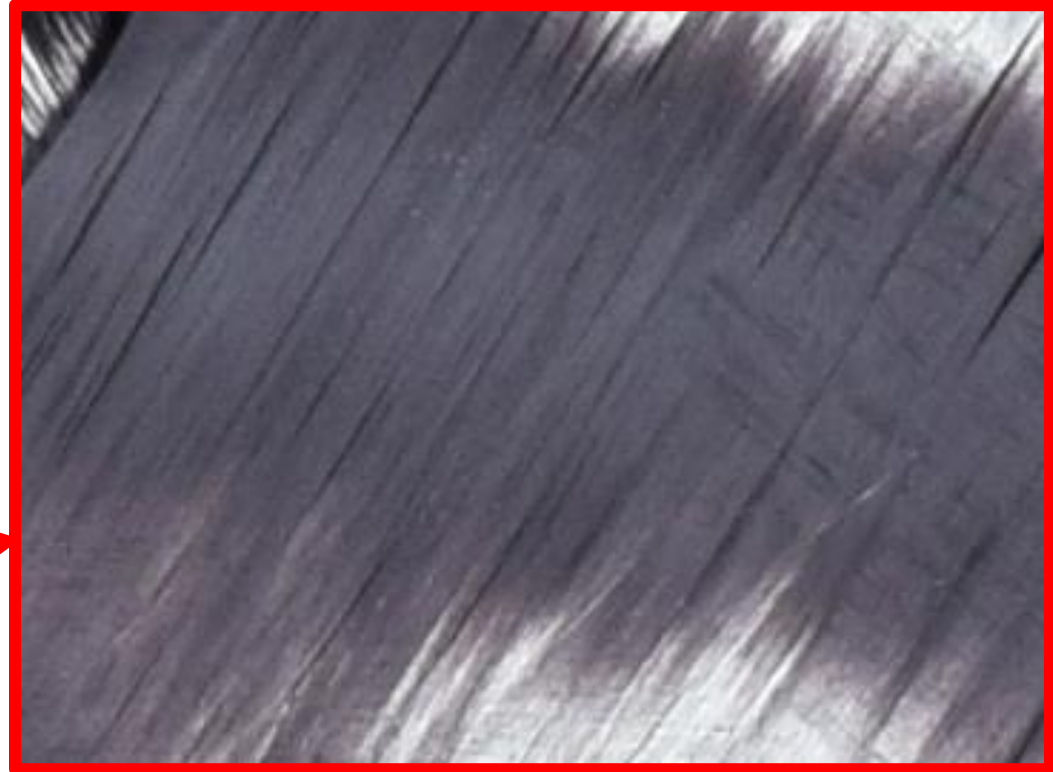
- ◆ No carbon fiber damage was observed in this test piece.
- ◆ CFRP damage during the vertical drop test was confined to delamination, with no damage to the carbon fibers

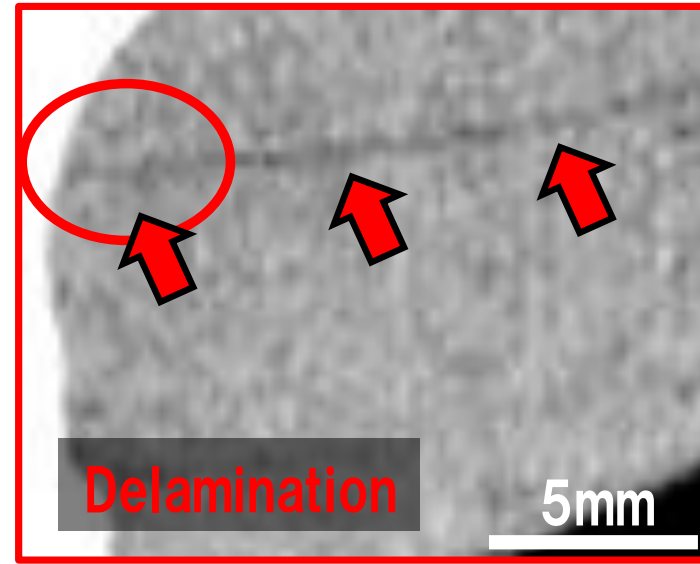
◆ Dome part

- ◆ The delamination that existed after the drop test further developed and became more **widespread** after the pressure cycling test, with part of the developed interlaminar separation **extending to the boss**.

1. The pressure cycling test propagated some of the delamination in the dome part, which was generated via the vertical drop impact.

→ The complex shape of the CFRP layer near the boss indicates that a **complex 3D stress** will likely be applied to the delamination when the container is distorted during the pressure cycling test.

2. Some of the developed delamination extended to the boss.

→ This finding suggests that the load sharing of the CFRP layer due to the delamination displacement fluctuates, thus decreasing the burst strength of the dome part.

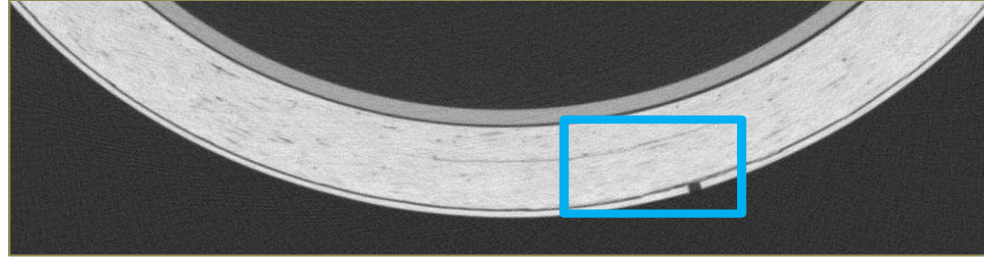
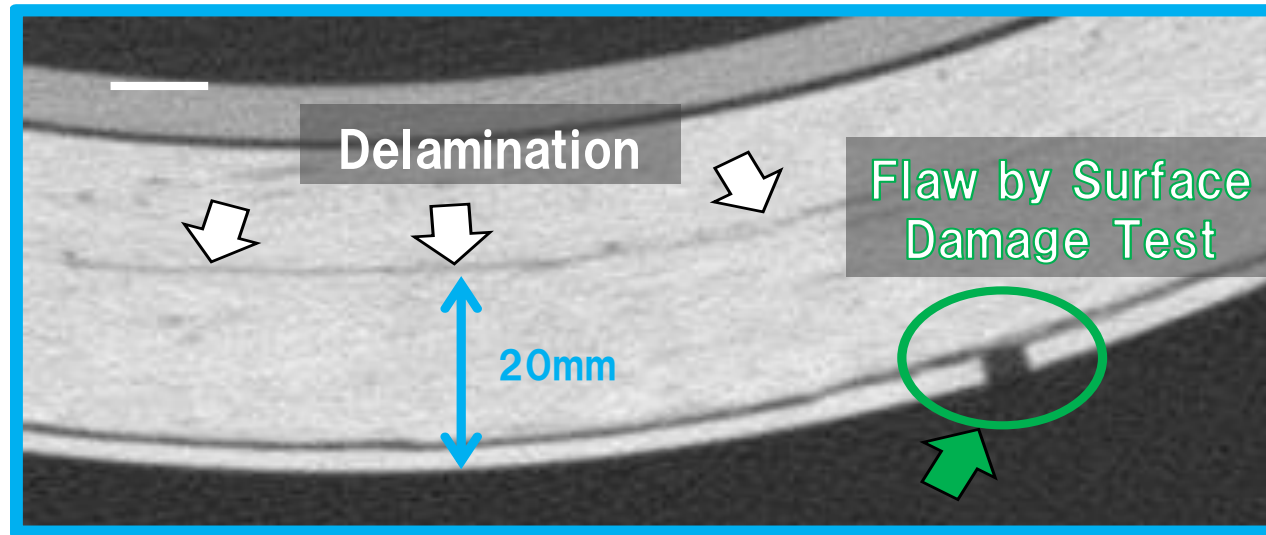
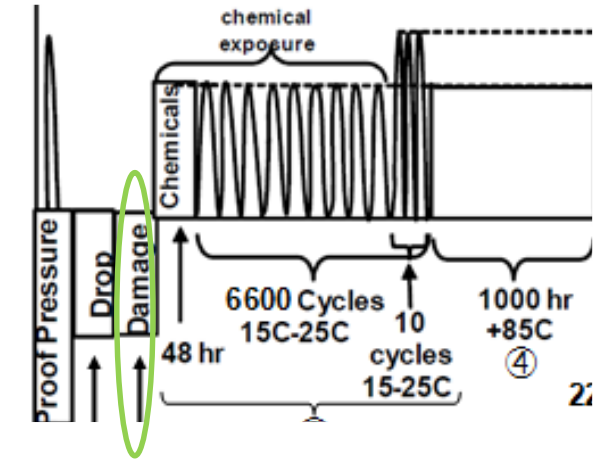
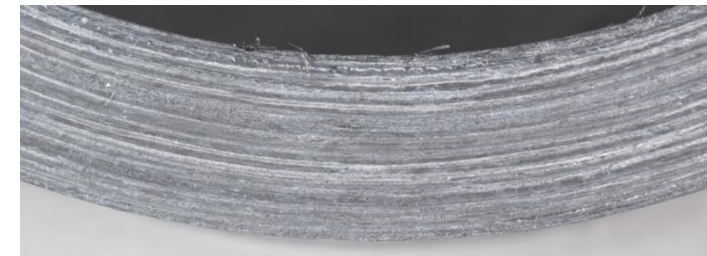
◆ Cylindrical part

- ◆ **Delamination has occurred at cylindrical part**
- ◆ The influence of the pressure cycling test on delamination in the cylindrical part of the container is not clarified since no X-ray CT images were acquired after the drop test.
