A STUDY OF DECREASE BURST STRENGTH ON COMPRESSED-HYDROGEN CONTAINERS BY DROP TEST

Masuda, S.¹, Tomioka, J.², Tamura, H.³ and Tamura, Y.⁴

¹ E-mobility Research Division, Japan Automobile Research Institute, 1328-23, Osaka, Shirosato, Ibaraki, 311-4316, Japan, mshun@jari.or.jp

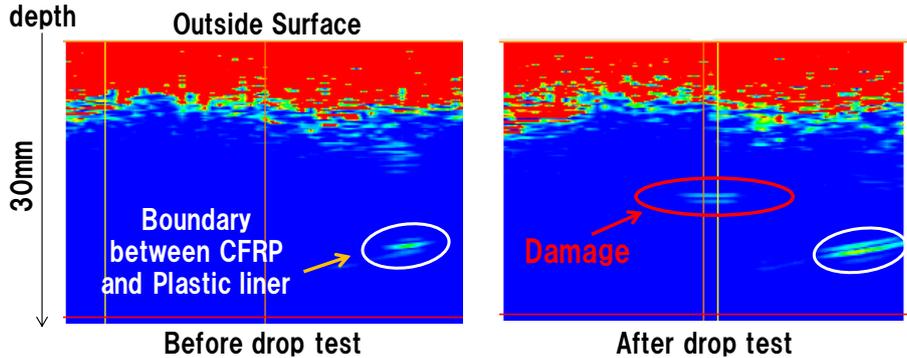
Figure 4. Ultrasonic inspection images (dome part)

Ultrasonic testing was conducted before and after the drop test. Figure 4 shows the measurement results of the drop test at the landing area around the dome part of plug side. The blue regions indicate that sound-wave reflections were not present, and the transition to red regions indicates a layer boundary or imperfection (e.g., air layer). The range of approximately 10 mm from the outside surface is shown in red; owing to the short distance to the probe, the reflection cannot be measured well. A comparison of the containers before and after the drop test revealed a clear reflection at approximately 20–25 mm depth. This reflection coincides with the boundary between the CFRP layer and plastic liner. Furthermore, a reflection is observed at a depth of approximately 15 mm after the drop test and extends parallel to the CFRP surface. This reflection is likely due to the damage incurred during the drop test because it is not observed in the container before the drop test. Figure 5 shows the measurement results for the landing site of the cylindrical part both before and after the drop test. Damage was incurred during the drop test, similar to that observed in the dome part. Figure 6 shows a summary of the test results. No damage was incurred away from the landing site of the drop tests, whereas the CFRP layer was damaged in all three directions (vertical, horizontal, and oblique directions) near the landing site.

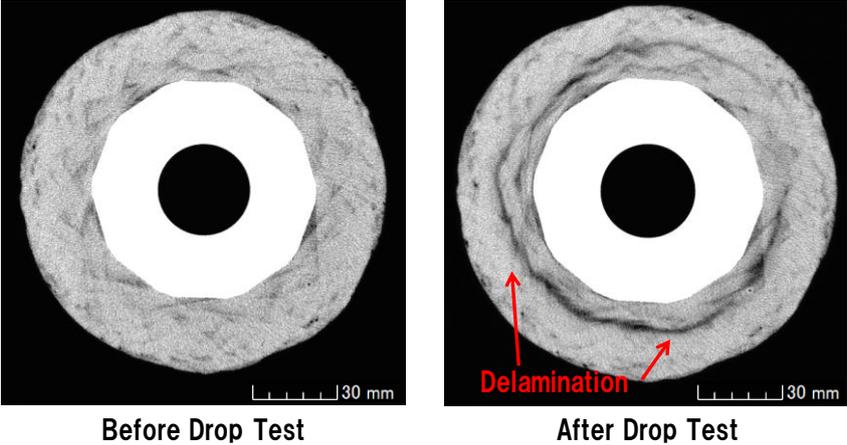
Figure 8. Drop test CT images (horizontal area)

Figure 8 shows a cross section of the plug side at the dome part of the container, both before and after the drop test. The black part in the image is air, the gray part is the CFRP layer, and the white part is the boss (plumbing interface). The CFRP layer contains an air layer after the drop test, it is afraid that an exfoliation is occurred. Furthermore, Figure 9 shows a vertically divided image created by combining the CT images. There were multiple deviations in the middle of the CFRP layer near the boss on the plug side of the container after the drop test. Figure 10 shows a cross-sectional image of the same part of vertically split image created from CT images of dome part. One CFRP layer extends in the direction of the white arrow and forms the dome part by overlapping several layers. These images suggest that this damage is delamination because of the observed exfoliation in the CFRP interlayer portion of the cross-sectional view. The above results indicate that the container damage induced by the drop test is the delamination of the structured CFRP layer. Furthermore, the delamination occurs near the boss on

the plug side by the drop test (vertical drop direction).

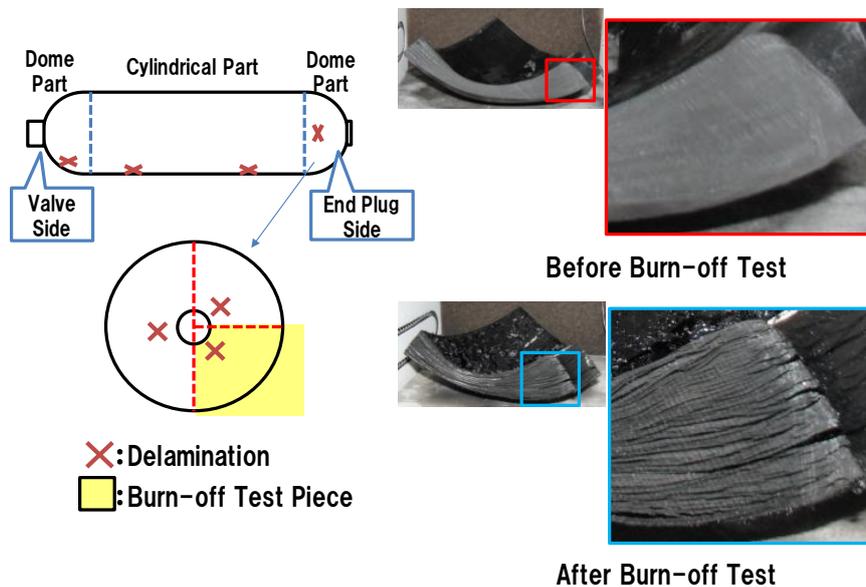
Figure 11. Burn-off test piece

The CFRP damage caused by the drop test is considered as a delamination and carbon fiber breakage. The ultrasonic test and X-ray CT imaging indicated that delamination occurred during the drop test, but these investigations cannot observe carbon fiber breakage. Therefore, we conducted a burn-off test to examine the degree of carbon fiber damage within the CFRP layer. A test piece was created from the container after the drop test (Figure 11). This test consisted of cutting a section of the container, including the point of impact from the boss in the dome part, and then creating a test piece from this container section. The test piece was then heated and maintained at approximately 500 °C by using an electric furnace. The CFRP epoxy resin was gasified, and the carbon fiber was extracted. Figure 11 shows the images of the test piece before and after the burn-off test. The test piece was separated into several layers after the burn-off test to investigate the degree of carbon fiber damage within the CFRP layer. Figure 12 shows a representative example of a burn-off test piece. No carbon fiber damage was observed in this test piece. Therefore, the CFRP damage during the vertical drop test was confined to delamination, with no damage to the carbon fibers.

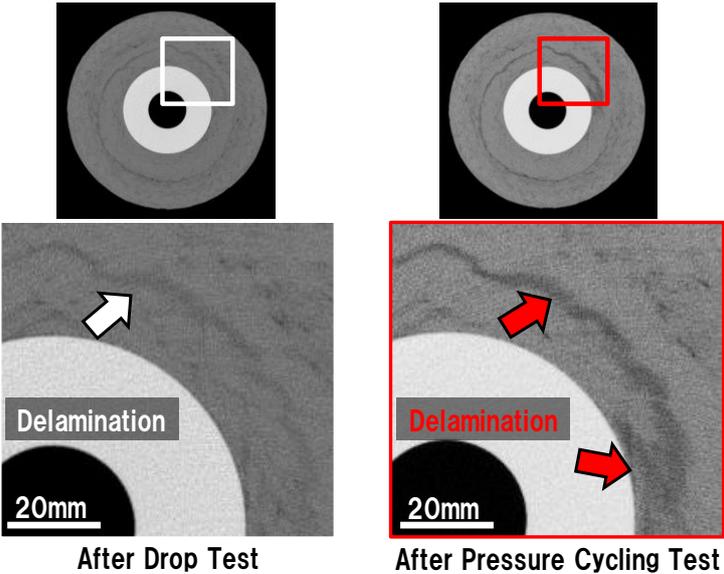
Figure 14. CT images of the horizontal area (delamination growth)

Figures 14–17 show the images of the plug side at the dome part after a drop test and after a pressure cycling test for comparison. The delamination that existed after the drop test (Figure 14) further developed and became more widespread after the pressure cycling test (Figure 15), with part of the developed interlaminar separation extending to the boss. However, the delamination gap decreased in Figures 16 and 17. This decrease may be due to the applied internal pressure that closed the gap during the pressure cycling test. Figure 18 shows a representative image of the cylindrical part of the container after the pressure cycling test (at a point 320 mm from the plug side). The flaws on the container surface indicated by the green arrows indicate damage from the surface damage test (No. 2 in Figure 1) that was conducted before the pressure cycling test. This test damaged the container surface via two specified types of wire scratches and a pendulum impact, and the green circle shows the cross section of a wire scratch with a depth of 1.25 mm or more. Furthermore, delamination occurred approximately 20 mm away from the container surface of the container to the dome part. The influence of the pressure cycling test on delamination in the cylindrical part of the container is not clarified since no X-ray CT images were acquired after the drop test.
