## Hydrogen related accidents and lesson learned from events reported in the in east continental Asia

### Abstract

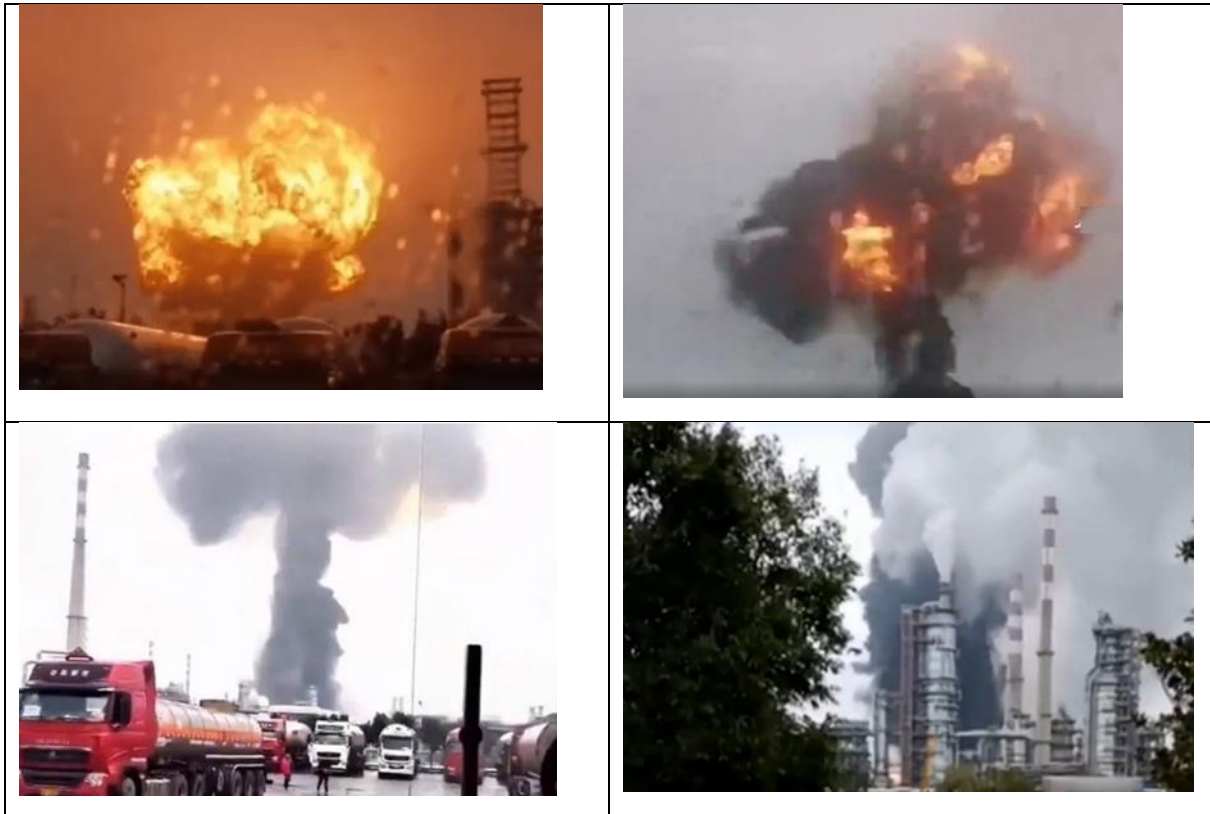
Causes: Both immediate and root causes are unknown. Although it is probable that hydrogen was at least one of the flammable gases contributing to the starting of the fire, without knowing the causes it is not possible to conclude on the role of hydrogen.

Figure 1: Video still from videos taken at the scene of the accident (Source: Web-news of 17 December 2021, available at <https://mp.weixin.qq.com/s/VXAhZhm4BDdUrLuY9cN5kA> (last retrieved 20.02.2023))

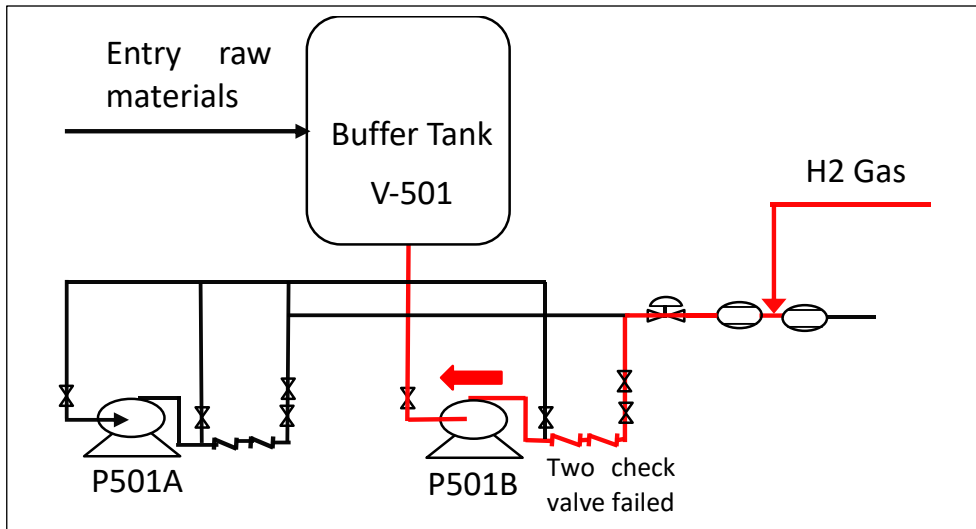
After the pump interlocked, the outlet valve was not closed in time and the two check valves failed. The high-pressure hydrogen gas in the system escaped into the tank. This caused an overpressure in the hydrogen buffer tank, which burst leading to a hydrogen-air explosion and a following fire, while diesel liquid spilled out to form a liquid pool on the ground.

Figure 2: After the hydrogen compressor has stopped working, the high-pressure hydrogen of the reaction system is reversed through the outlet check valve P501B into the V501, ref [1].

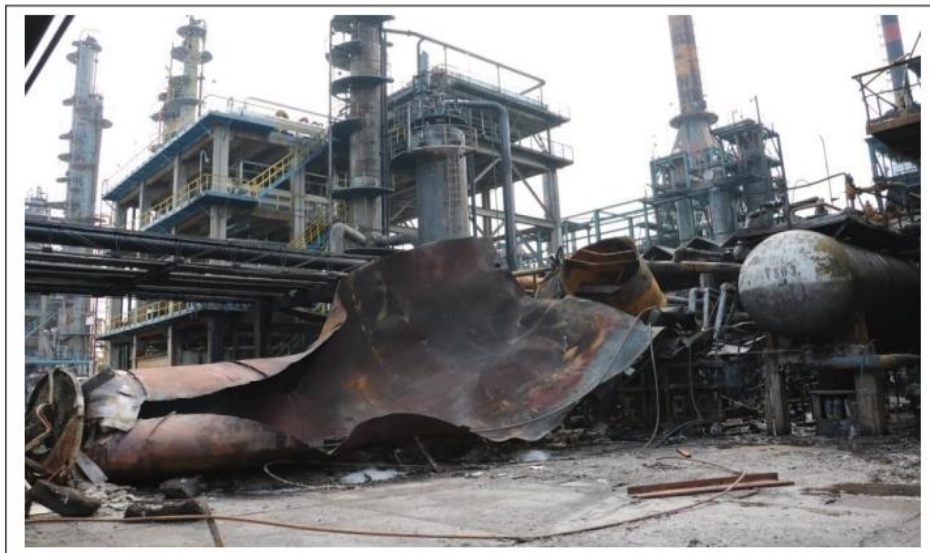
Causes: The immediate cause of the explosion was due to the tank being erroneously filled up with hydrogen. Part of the root cause sequence was the wrongful operations of the operator. However, if an operator executes a wrong action, the root cause could be lack of instruction, lack of training, or shortcomings in the design.

Figure 3: Damaged tank shown in accident scene, ref [1].

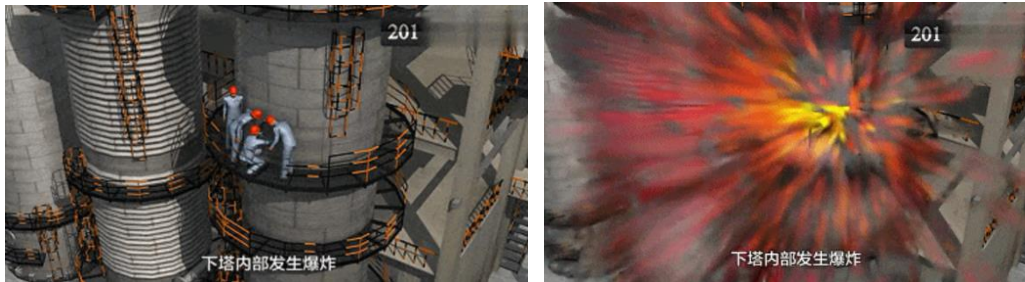
Causes: Immediate cause was the pure hydrogen inlet line shut-off valve leakage, and hydrogen gas was strung into the tower and mixed with the air entering from the upper manhole, which exploded when it met the ignition source. Contributing cause was the fact that the personnel of the enterprise did not take effective isolation and entered the lower tower of the hydrogenation tower to work. Root cause was a complete lack of risk management, no maintenance procedure, no risk assessment, no mitigation measures.

Figure 4: Video still from the accident scene simulation video (Source of the video: <http://3g.k.sohu.com/t/n478449026>)

Lesson learned: Equipment maintenance and management were not in place. Since the hydrogen peroxide plant was put into operation, no regular overhaul had been organised and no regular maintenance. During the event that internal leakage of the valves were found, no effective measures were taken in time, resulting in hydrogen being strung into the lower tower of the hydrogenation tower due to internal leakage of the valves.

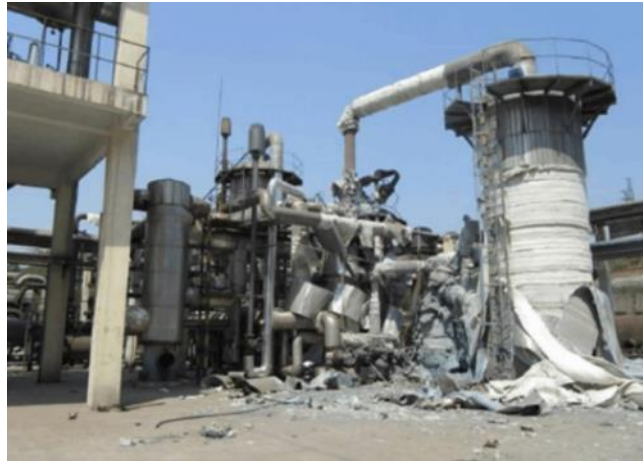
Event description: the day before the incident, the outlet pipe connected to methanation reactor started leaking gas, which contains hydrogen. The leak was temporarily eliminated by a pressurised plug. On the day of the incident, the pipe leaked again, and the same plugging method was still used to stop the leak. This occurred without shutting down the unit and taking safety measures. Approximately one hour later, a sudden explosion occurred at the inlet line of the methanation reactor. The welded joint of outlet pipes that connected to the methanation furnace was operating for a long time in the high temperature hydrogen containing medium. Under this condition, hydrogen embrittlement took place, producing local defects and eventually opening up. The released hydrogen ignited and exploded.

Causes: the immediate cause was hydrogen corrosion which caused a crack and a gas release. Attempts to stop the leak by temporary measures were executed without stopping the operations and no additional safety measures being put in place were definitively part of the root causes.

Figure 5: Accident scene after the explosion (picture source: website <https://www.renrendoc.com/paper/126162606.html>).

Lesson learned: In the petrochemical industry, leakage often occurs due to the increasing corrosion problems caused by the deterioration of processing raw materials, production, storage and transportation. Leak plugging technology is often being used to ensure the safe and long-term operation of the plant. However, leak plugging with pressure has high operating pressures, which makes it very easy for safety incidents to occur during operation. It is worthwhile to study how to carry out fast and effective leakage plugging under safe conditions, and to standardize the leak plugging technology with pressure.

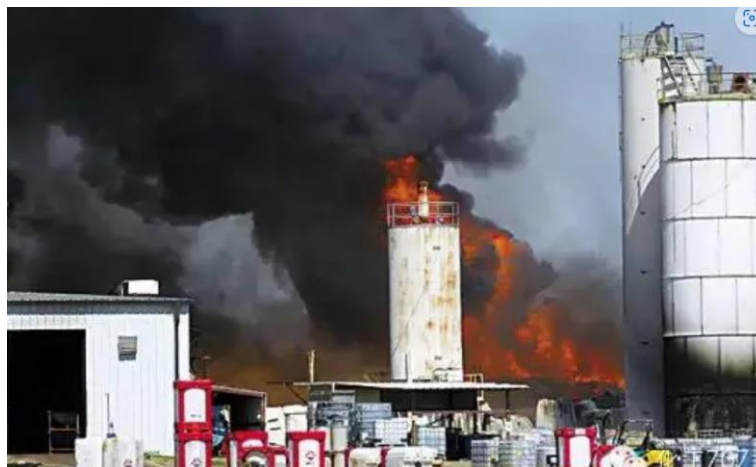
Event description: a gas mixture (25% nitrogen, 73% of hydrogen, 2% methane) leaked, due to the ejection of the check valve from its connection with the inlet pipe. A large amount of the gas mixed with air and ignited, probably due to sparks generated by the ejected check hitting a metal pipe. It followed an explosion. Its pressure wave hit a gas pipeline causing its fracture and a fire. After about 1 hour and 30 minutes the fire was under control. The shockwave from the explosion caused a gas pipe at the back of the workshop to crack and leak, causing a large fire.

Causes: The immediate cause of the incident is the sudden falling-off of the check valve, due to a large deviation of the dimension of the small diameter of the inner flange thread. Its diameter was too small and eventually lead to the separation of two connections. The root cause is related to quality control not properly done and failed inspection.

*Figure 6: Accident scene after the fire (picture source: website <https://www.ichemsafe.com/info/3275.html> (last retrieved 20.02.2023))*

Lesson learned: The plant operator has to establish and implement a qualification system for purchased components. This will allow the early detection of wrong or not certified materials. Moreover, an inspection system has to be in place, to assess additional risks related to components replacements and repair.

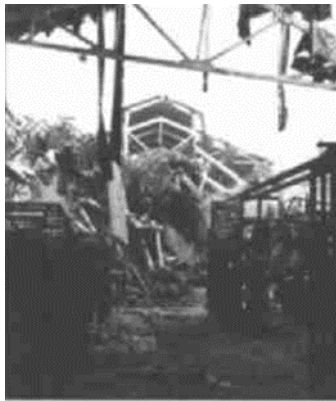
Event description: A gas (mixture of hydrogen and nitrogen) release occurred in the factory building. It occurred at the outlet valve, during works aiming to replace it. This caused the creation of an explosive gas mixture in the circulation room and surrounding spaces. The valve problem has been found since several years, the poor design and wear caused hydrogen gas leakage. The ignition took place with 9 minutes delay after initial leakage.

Causes: the immediate cause was a leak of a mixture of hydrogen and nitrogen from a defective valve. Since the ignition occurred several minutes later, the hydrogen had the time to form a large flammable cloud within the building. The delayed ignition very possibly led to a detonation.

Figure 7 - Scene after the incident (source of the picture: [Knowledge Network Node -> link to accident report](#), retrieved 20.02.2023).

Lesson learned: effective safety measures should be immediately taken after leakage to prevent fire and explosion; valve should be replaced once the problem was found.

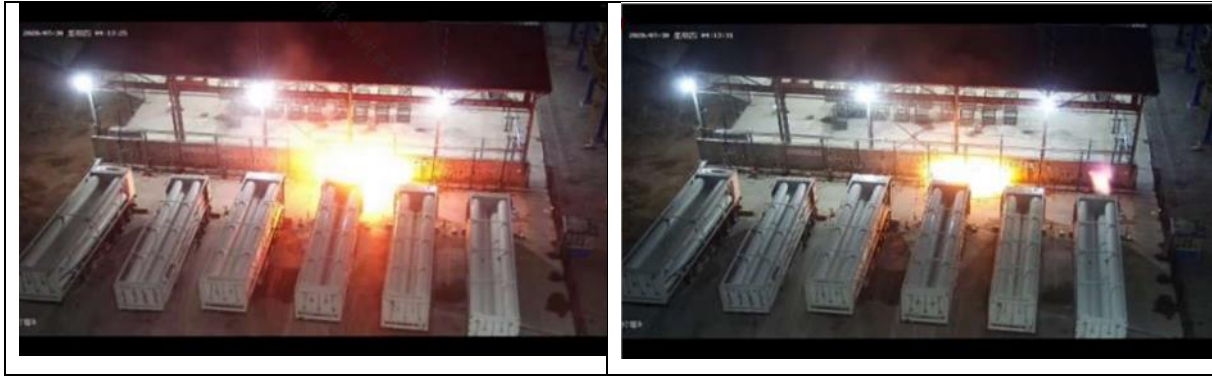
The fire resulted in damage to the pipes, valves and other accessories of the two hydrogen bundle containers.

Figure 8 -A) Hydrogen leak from the hose in front of the trailer. No. 4 burst into flames; B) Hydrogen leaking from the loading and unloading ports on trailer No. 6 burst into flames (Source of the pictures: Investigation Report on the "7-30" General Leakage and Fire Accident at Dongguan Juzhengyuan Technology Company Limited, Lixia Island, Shatian Town, Dongguan City).

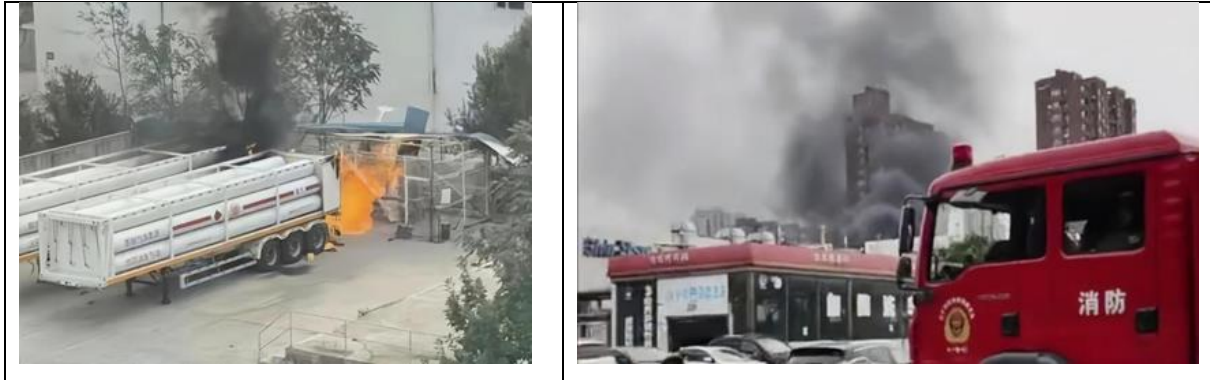
Figure 9: Fire starts from trailer (Source of the pictures: <https://new.qq.com/rain/a/20210807A02SN600>, retrieved 20.02.2023).

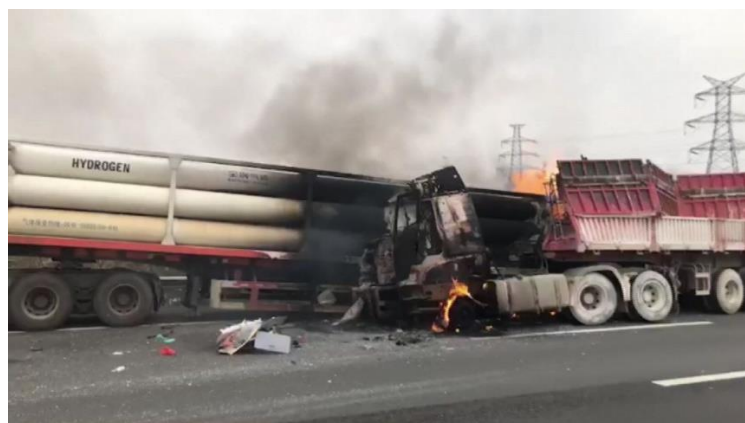
Figure 10: Trailer carried hydrogen gas ended by a truck in motorway (source of the picture: [Link to the media](#), retrieved 20.20.20123)

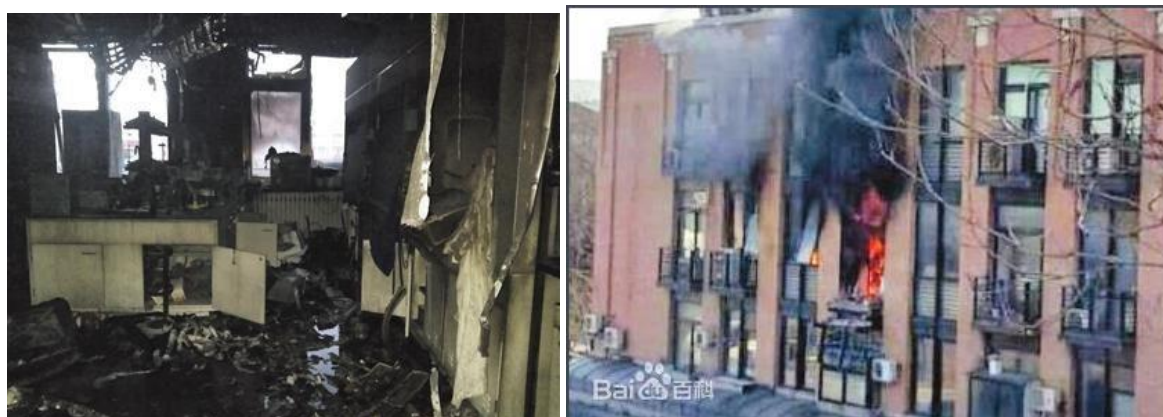
Figure 11: Laboratory after the explosion (left) and external of the university building during the fire (source of the pictures: Source: [Link to the media](#), retrieved 20.02.2023)
