# Field test series for development of mitigation barriers and its designs against hydrogen explosion

# Motivations of Project

# Mitigation Barriers in KGS Codes

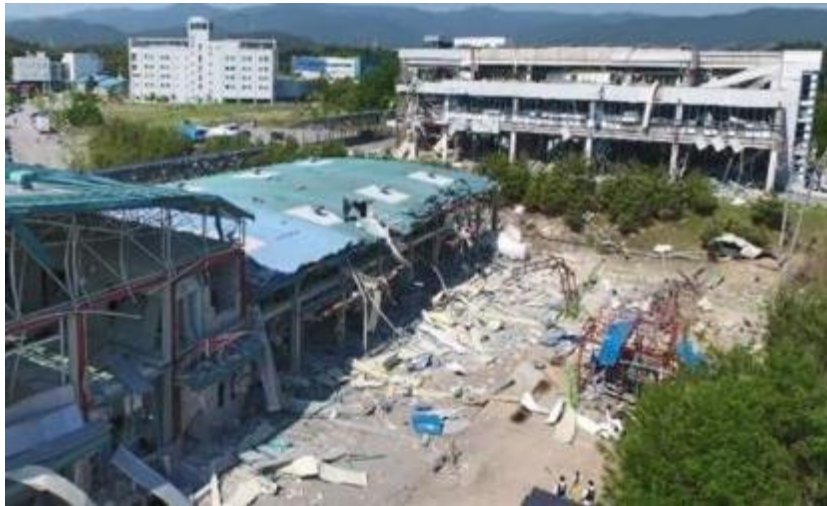
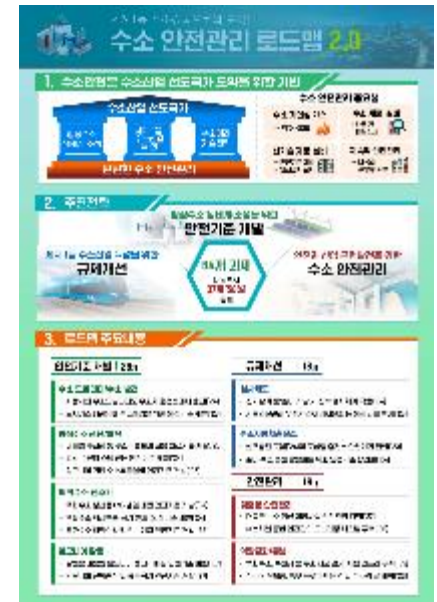
- Explosion of hydrogen tanks in South Korea (2019.5)
  - Consequences are 8 victims (2 fatalities), property loss up to 26.8 M Euros
  - Findings are *no blast mitigation* prepared; and significant *overpressure beyond 30 m*
- National research projects for safety of hydrogen infrastructures (2021.5)
  - One is to find out *safe designs of blast mitigation barrier in HRS*
- Hydrogen Safety Management Roadmap 2.0 (released by MOTIE, 2023.5)
  - To *improve regulations* based on *evidence* including safety distance, mitigation, etc.

Consequences of the incident (2019.5)

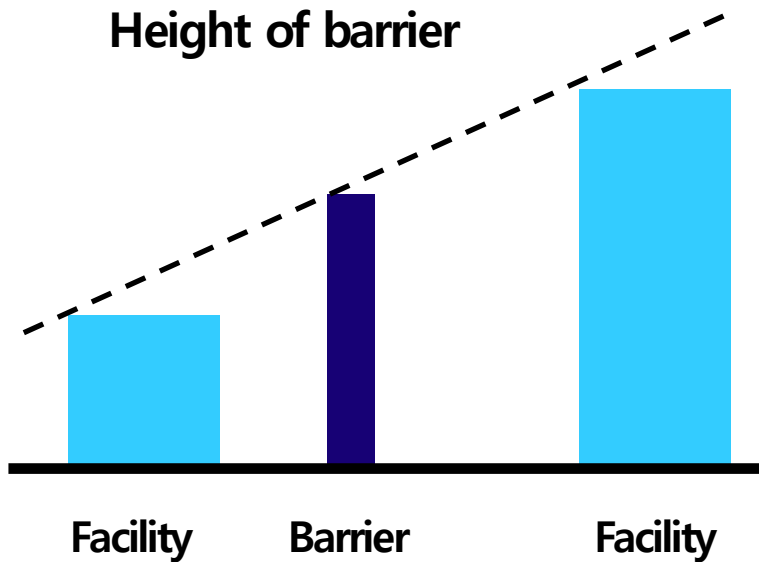
Side View

## Sizing | Minimum Height and Width

**“The barrier should be installed so as to block propagation of risk source in one section into the other sections”**

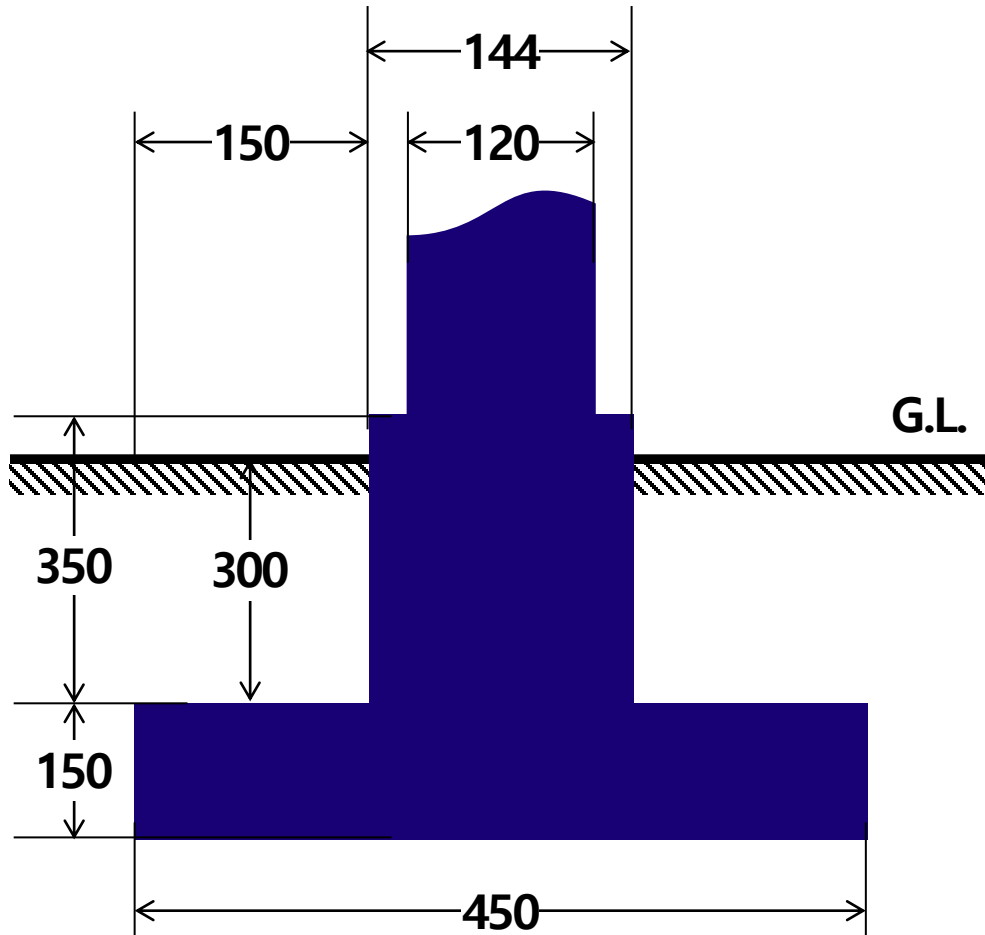
Side View of RC Barrier on Foundation

- Monolithic barrier and foundation
- Steel rebars
  - diameter: 9 mm
  - spacing: 400 mm

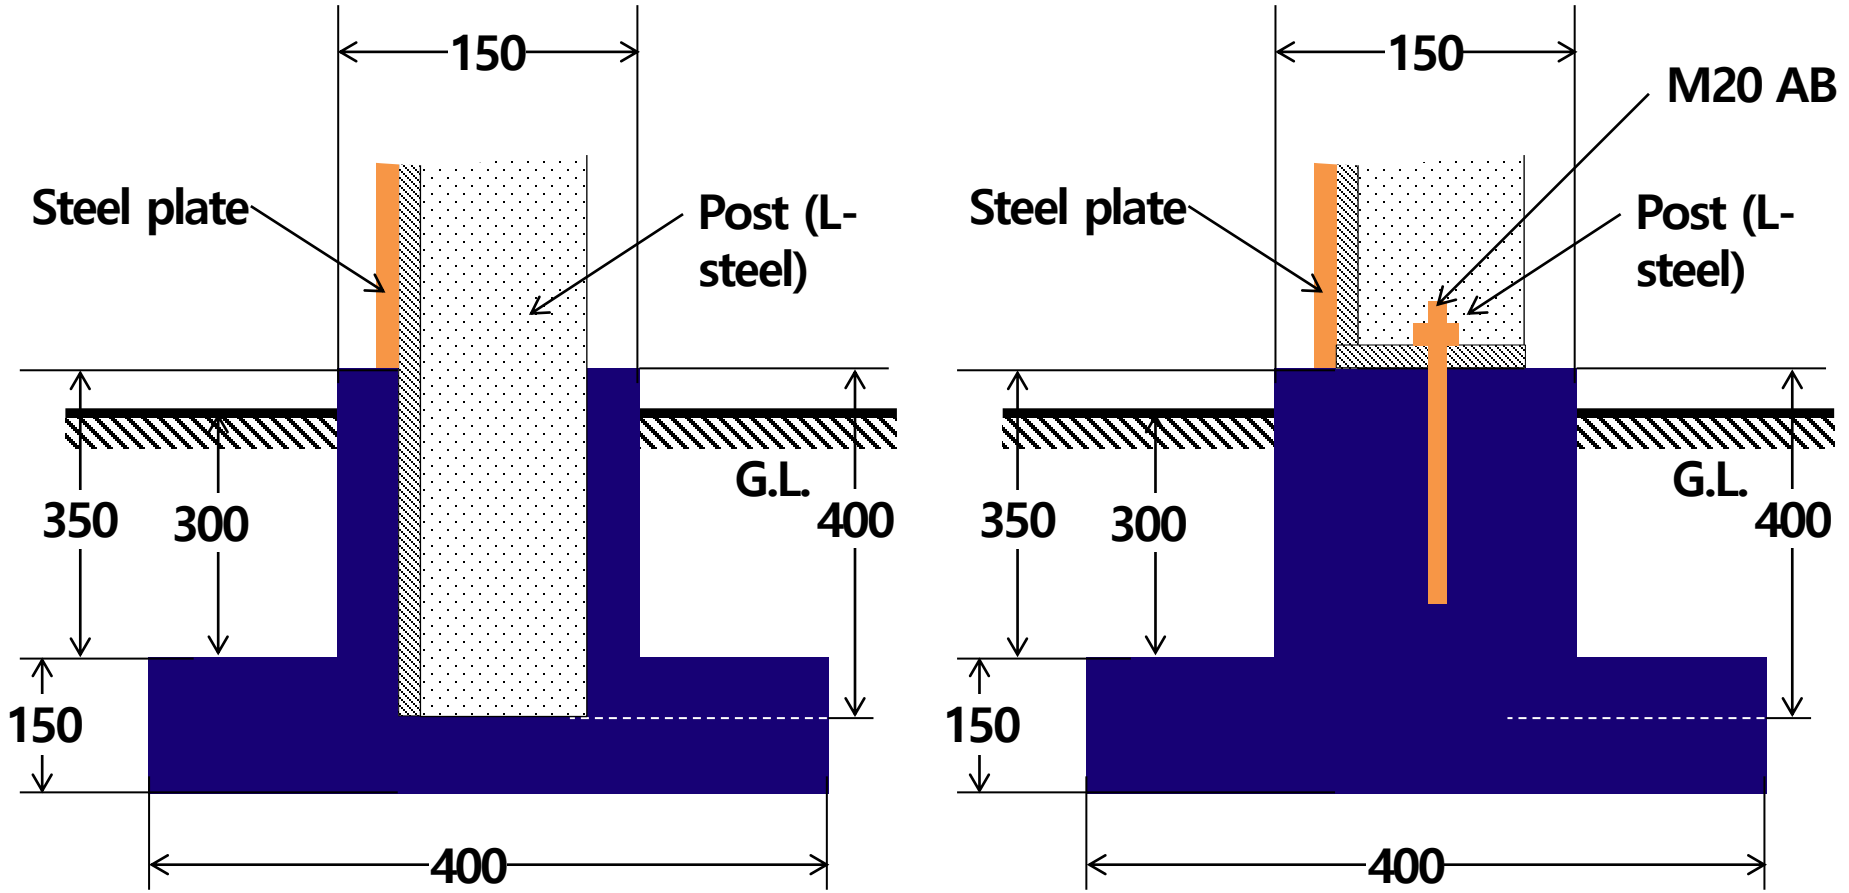
Side View of Steel Barrier on Foundation

- **Thickness of Plate**
  - 6 mm, or
  - 3.2 mm + Reinforcement with 30-mm angled steel (spacing of 400 mm)
- **Post**
  - 100 x 100 mm

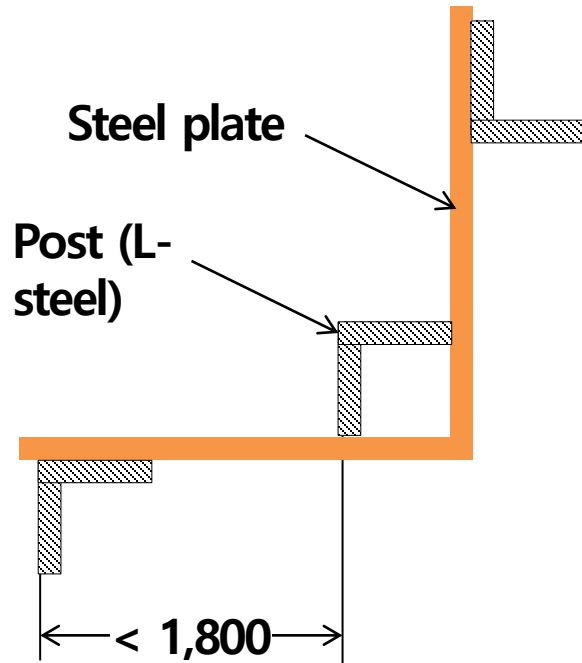
U-, H- Beam are also allowed

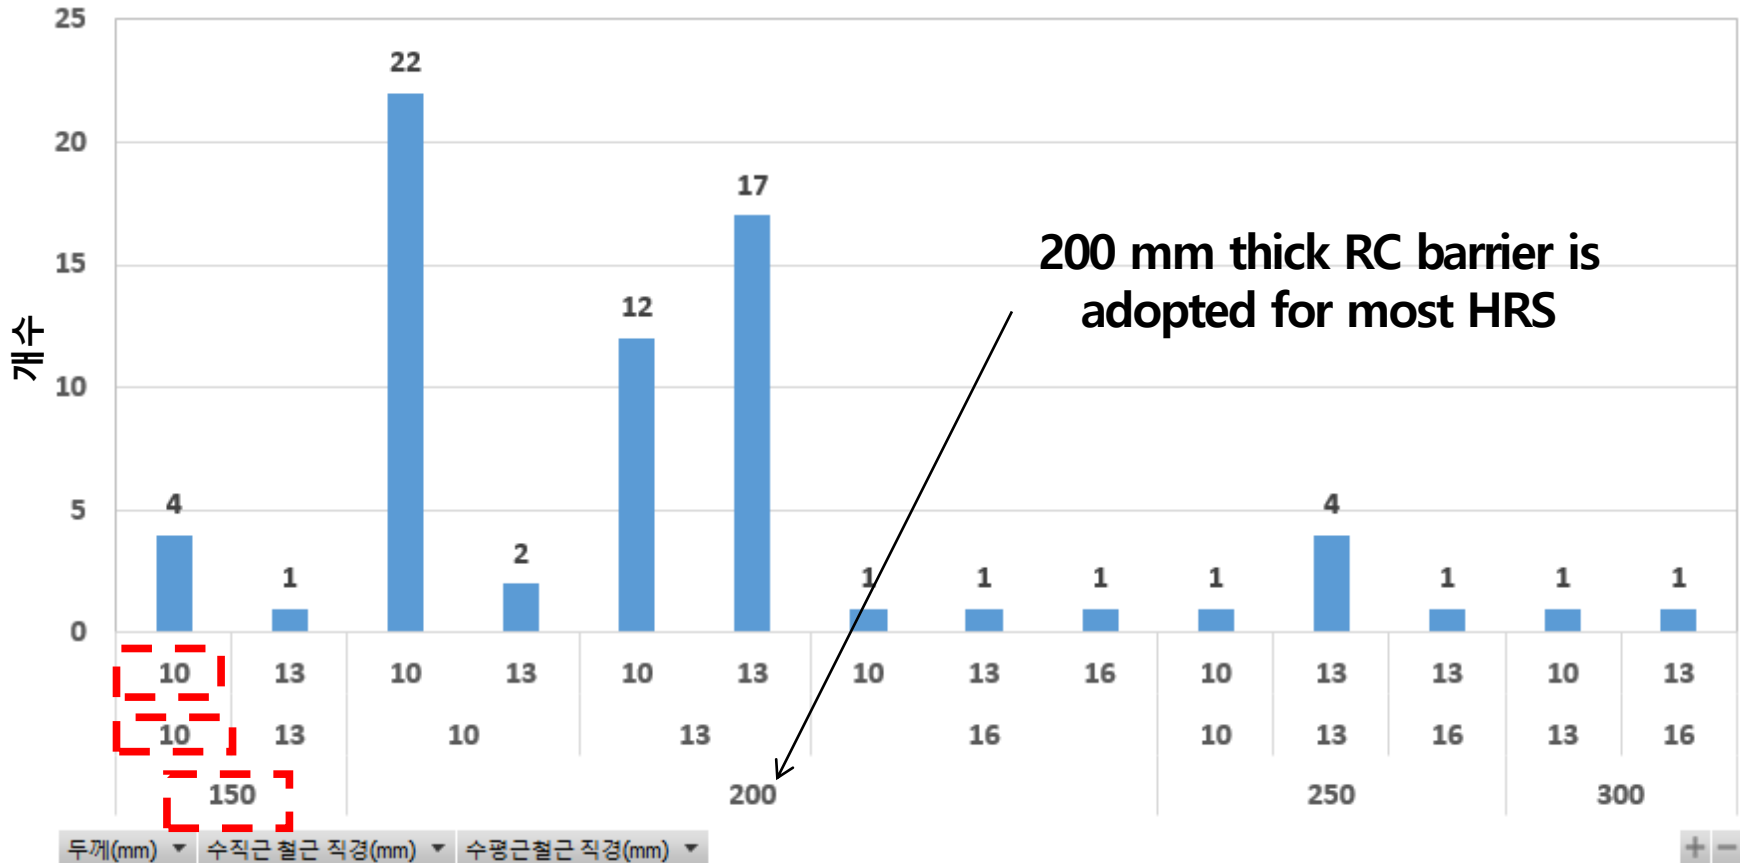
Statistics for barriers in HRS: wall thicknesses and diameters of rebar

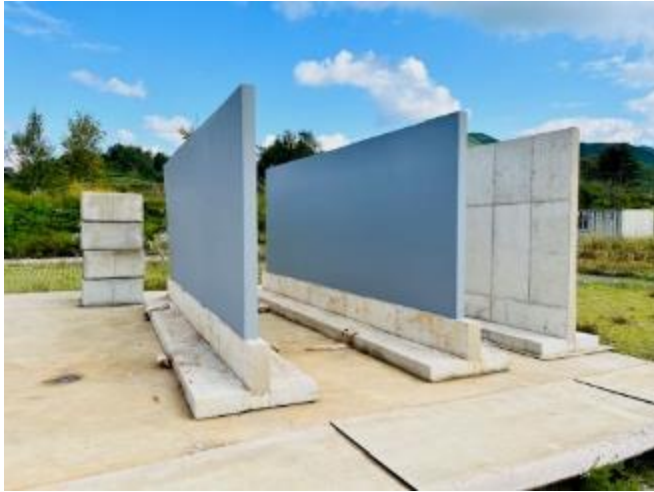
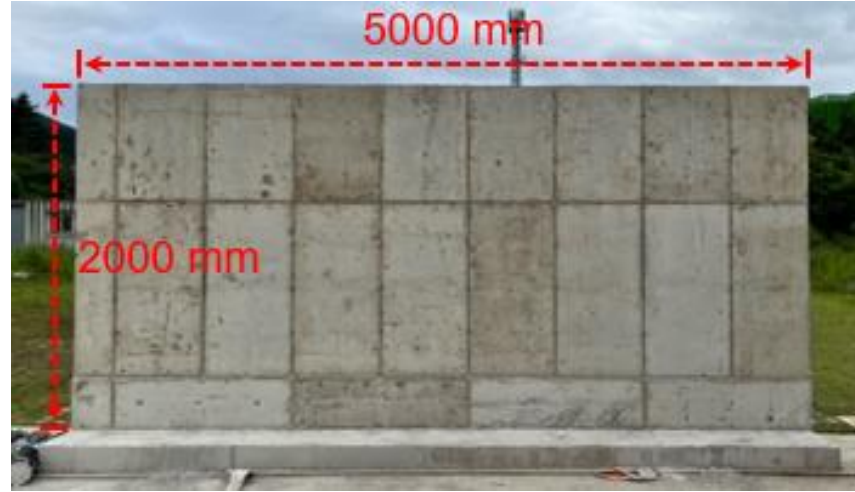
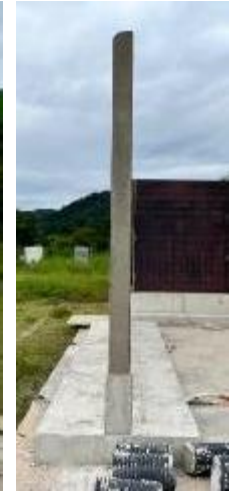
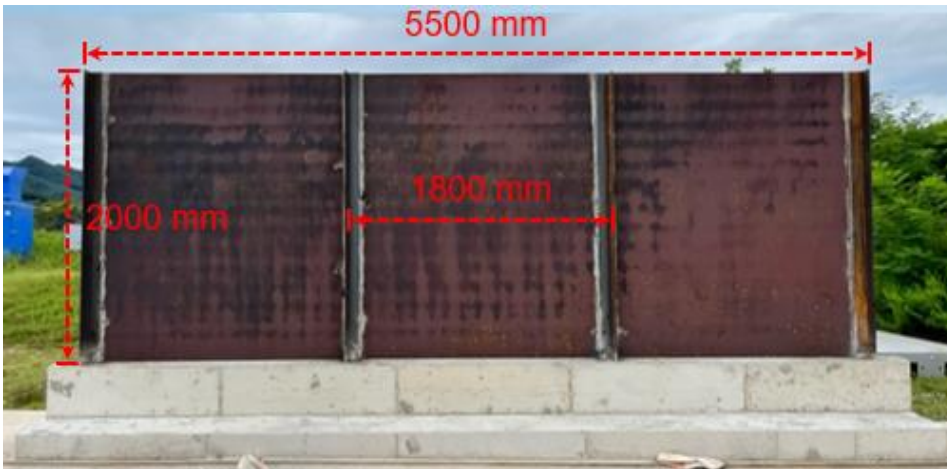
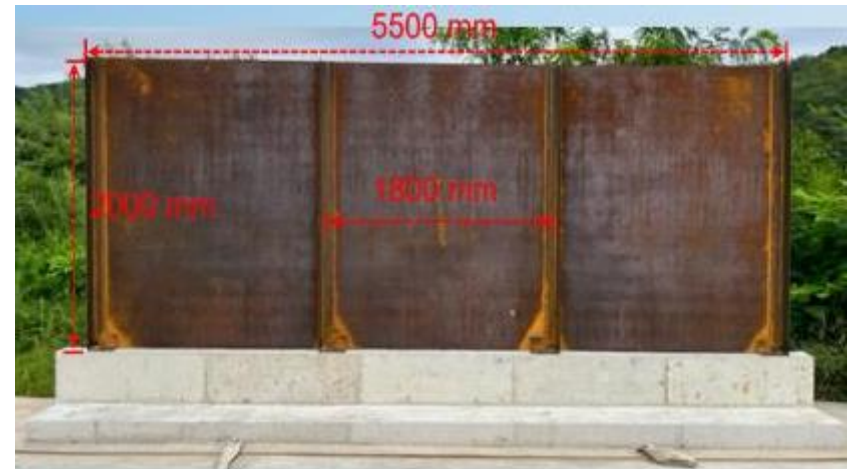
- **Explosion source: Approx. 7 kg of hydrogen (i.e., 175 L @ 70 MPa)**
  - A type-4 cylinder (TPRD disabled), heated by a planar LPG burner until it blows up
- **Test specimens: 3 types of mitigation barriers with the minimum designs**
  - 1 reinforced concrete barrier, 2 steel-plate barriers(posts are buried in foundation; posts are mounted on foundation with anchor bolts)

## Preparation of Test Specimens | Mitigation Barriers

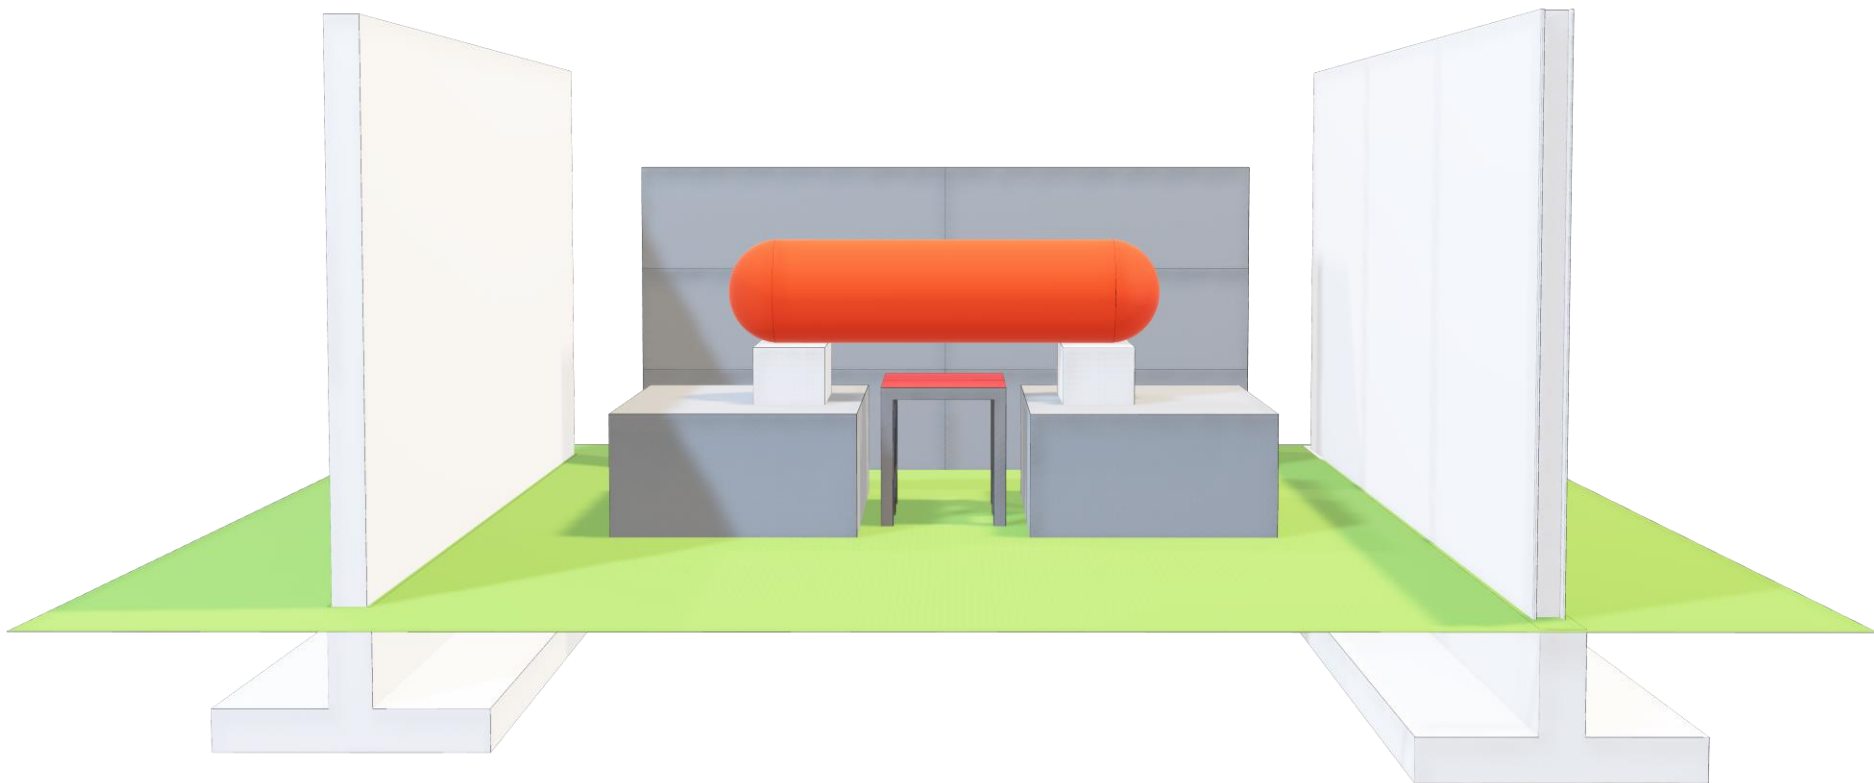
## Test Plan | Barriers & Heated Hydrogen Cylinder

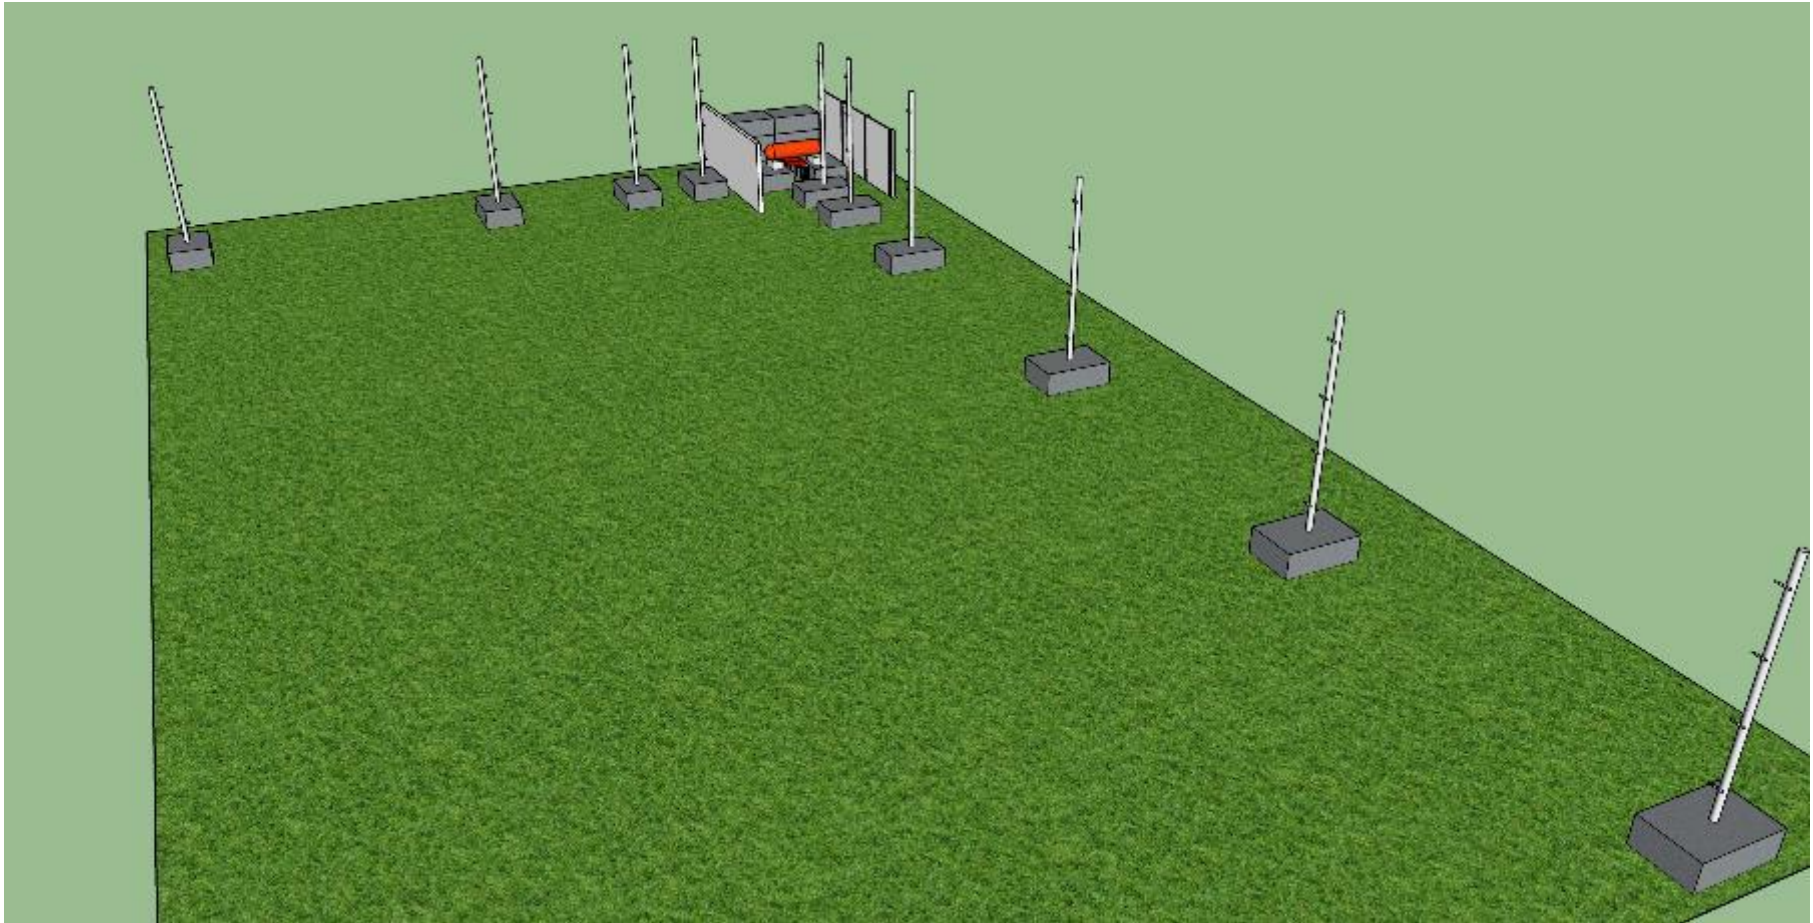
## Test Plan | Overpressure Measurements

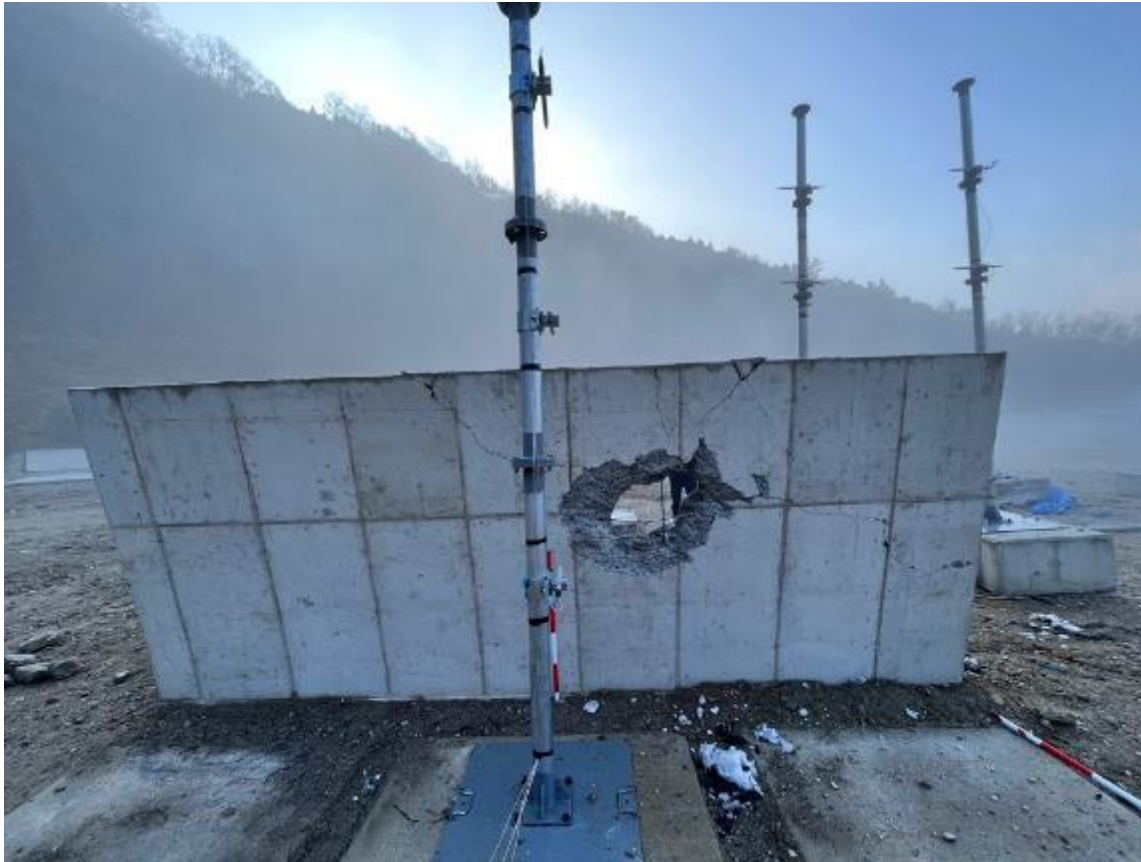
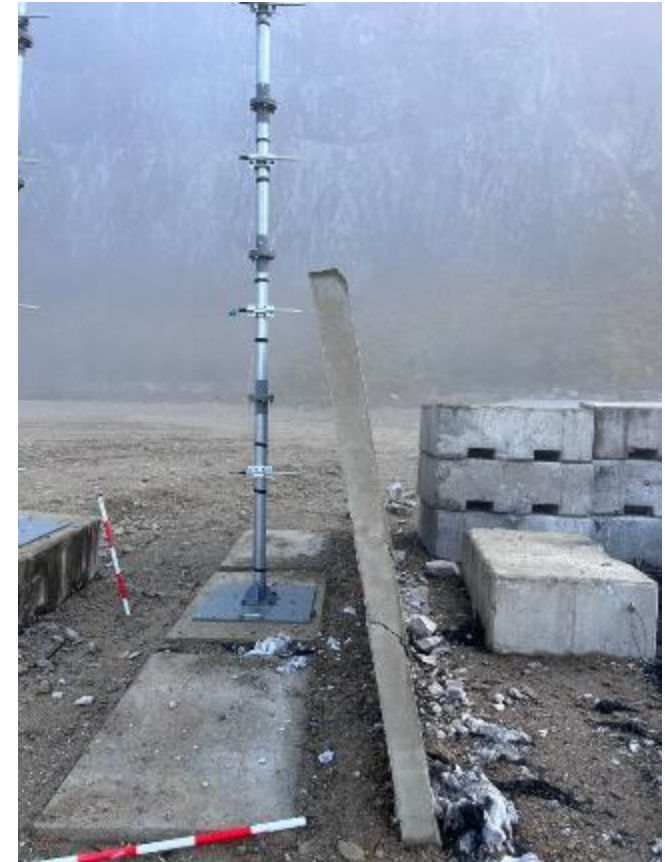
**Summary:** a hole created; many horizontal closed cracks found; wall tilted out; debris (> 1 kg) found even in 30 m; overpressure measurements beyond barrier failed

- **Structures of all types of specimens were seriously damaged**
  - **Thicker reinforced concrete barrier should be tested**
  - **Improvement is necessary to hold posts of steel-plate barrier firmly to foundation**

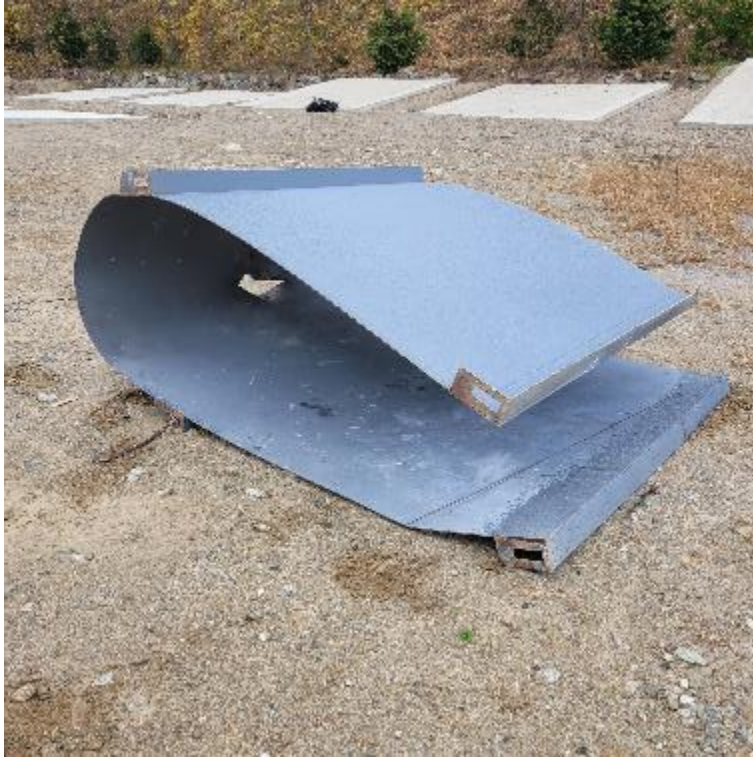
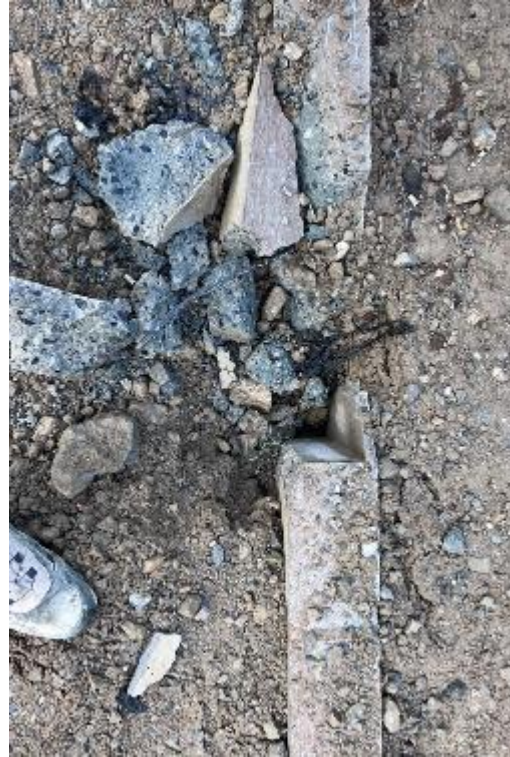
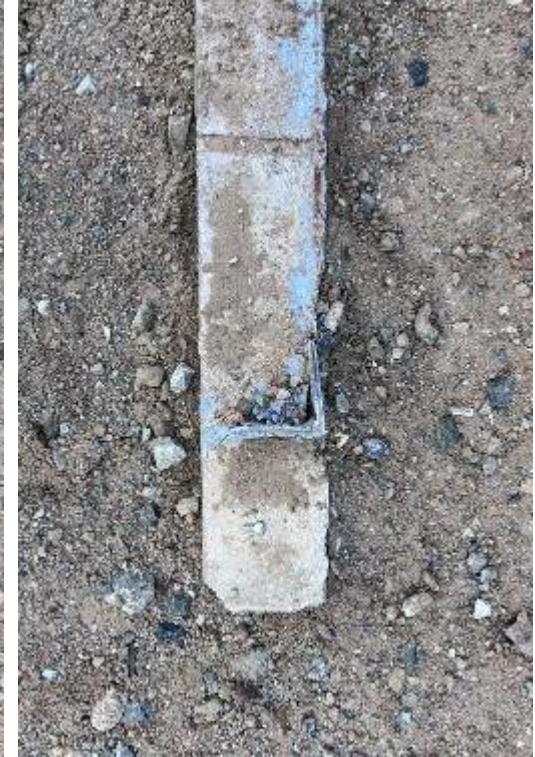
**Summary:** both walls pulled out from foundations and flew away approx. 25 m; foundations destroyed; welded part in post cut out; no crack found on walls; a small hole created without flying debris

- **No debris implies that steel plate barrier may provide better protection**
- **The results of overpressure measurements**
  - **The overpressure data are still under investigation, therefore the consequence cannot be asserted yet**

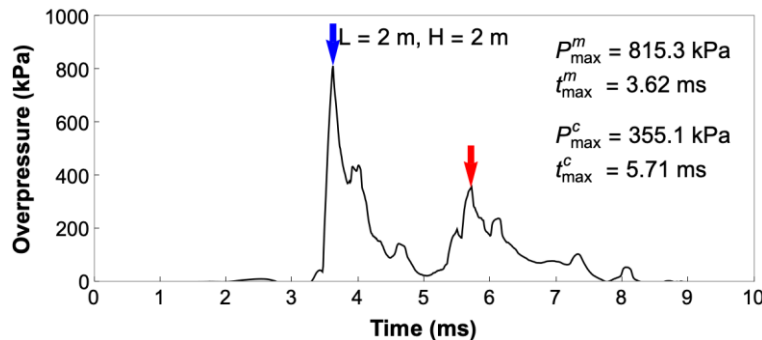
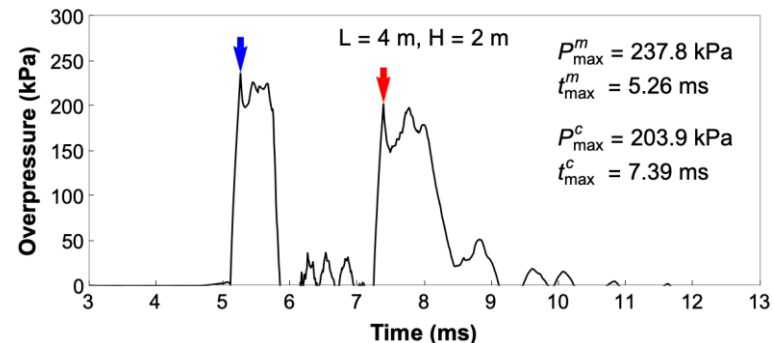
### Example of overpressure readings in different distances at 2 m from ground

Overpressure profiles:  $P^m$  mechanical explosion;  $P^c$  chemical explosion

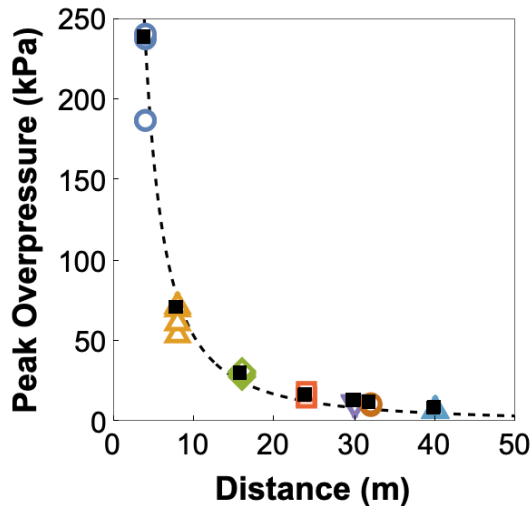
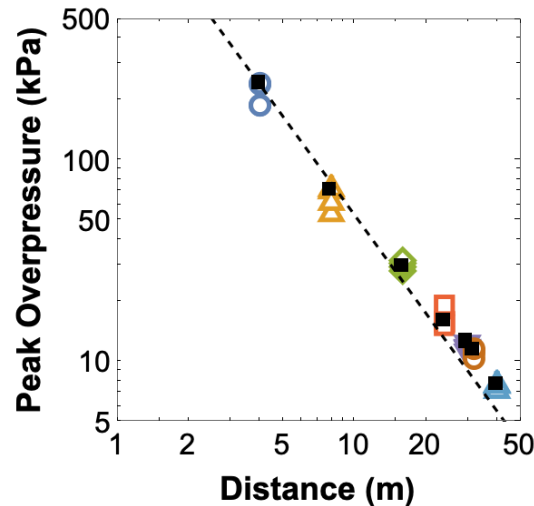
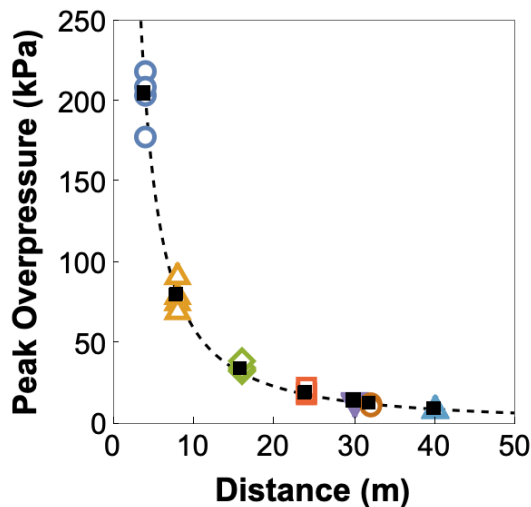
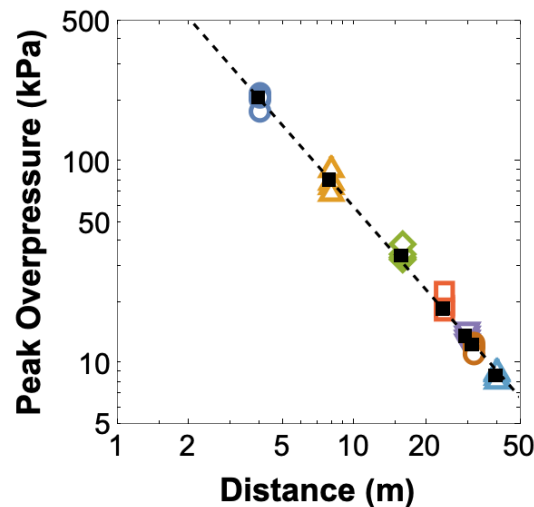
- Peak overpressures by both mechanical and chemical explosions are in exponential decrease to distance
- At 30 m, human may survive, but building is in question

- **Exponential decay in peak overpressure were seen, and the safety distance of 30 m may be good for human, but in question for building**
  - **In the future, for computing TNT equivalence, overpressure measurements at the same locations will be conducted when different masses of TNT are exploded**
