Explosion Replication Test of FCEV Hydrogen Tank

Park, B. and Kim, Y[†]

¹ Researchers, Department of Fire Safety Research, Korea Institute of Civil Engineering

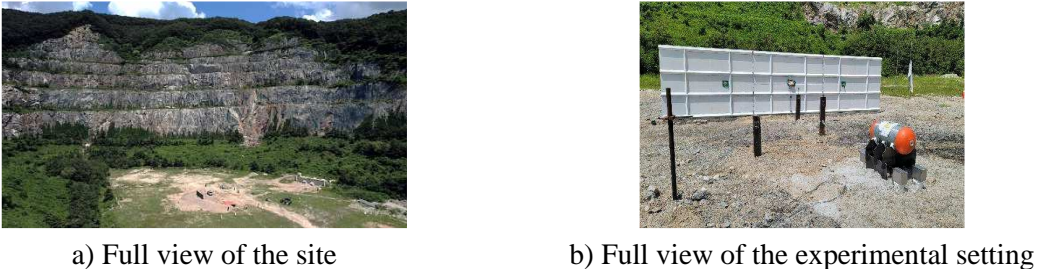
Figure 1. Experiment view

To minimize concussive interference when measuring the incident pressure, the experiment was conducted in a wide space (Fig. 1(a)). The experiment consisted of three explosion tests using three FCEV hydrogen tanks pressurized to 700 bar (2.1 kg H₂), 350 bar (1.05 kg H₂), and 10 bar (0.003 kg H₂), respectively. The pressure of each hydrogen tank was raised by an external fire source. The TPRD was removed, and the resulting opening was sealed to amplify the pressure within the tank.

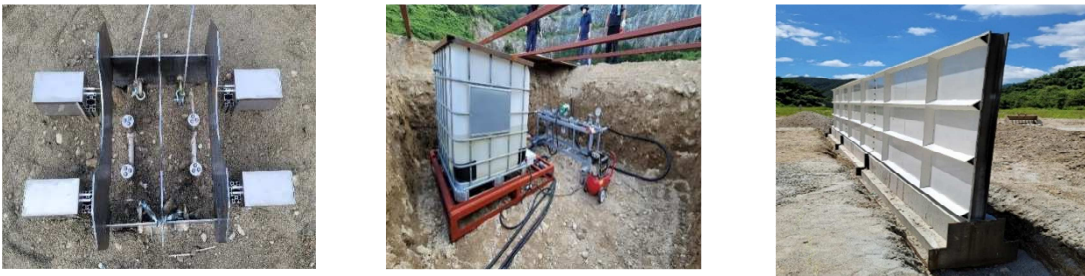
Figure 2. Snapshots of the accident scenario replication devices

(a) Heptane nozzles and ignitor (b) Heptane fuel tank and supply system (c) Installed protective barrier

The explosion tests were conducted following the UN GTR 13 protocol [10, 11], replicating a pool fire accident under a hydrogen tank. As shown in Fig. 2(a), a heptane burner with twelve spray nozzles, designed to release heptane at a flow rate of 0.9 LPM, and a mounted ignitor were positioned beneath the tank. The arrangement of the pressure transducers relative to the hydrogen tank and a protective barrier is shown in Fig. 3. A 4.5-mm-thick steel (2 m × 10 m) protective barrier was installed on a reinforced concrete base, following the steel panel protective barrier installation standard (KGS FP217 [24]). Three reflected pressure transducers (1.2 meters high) were positioned over the protective barrier, as shown in Fig. 4(c).

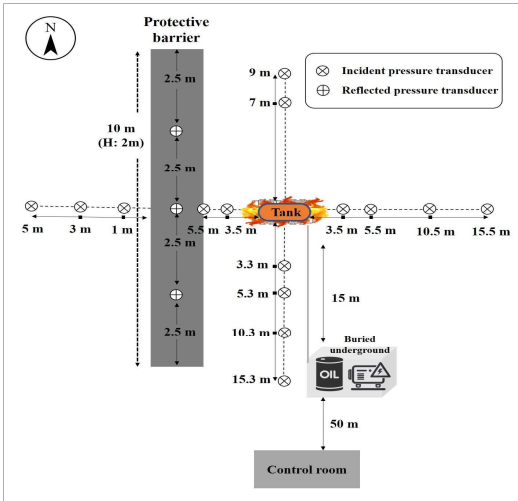
Figure 3. Arrangement of measurement devices

When measuring the peak overpressure, two separate components were measured: incident and reflected overpressures. Fifteen incident pressure transducers (H:1.5m) were positioned along the four cardinal directions, with the hydrogen tank placed at the center of the arrangement. Four units were placed to the east of the tank (at distances of 3.5, 5.5, 10.5, and 15.5 m), two units to the west (3.5 and 5.5 m), four units to the south (3, 5, 10, and 15 m), and two units to the north (7 and 9 m). The protective barrier was installed 5 m to the west of the tank, and three incident pressure transducers were positioned behind the barrier (at distances of 1, 3, and 5 m from the barrier). The fuel tank and supply system were installed underground 15 m from the hydrogen tank. The experiment was conducted from a control room located 50 m from the explosion test site. Specifications of the measurement devices are listed in Table 2. A data logger was used to record the electric signals transmitted from the fifteen incident pressure transducers and three reflected pressure transducers (Fig. 4) at a data transmission rate of 1 million samples per second.

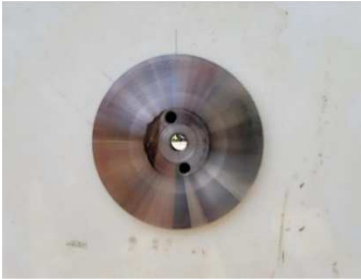
Figure 4. Photos of the measurement devices

a) Incident pressure transducer (blast pressure pencil probe, PCB)

b) Reflected pressure transducer

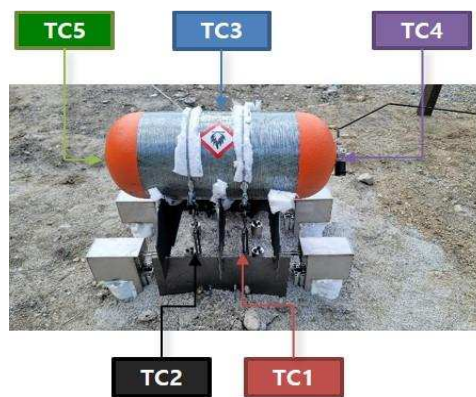
Figure 5. Thermocouple measurement locations

As illustrated in Fig. 5, five thermocouples (K-Type) were placed around the tank: one each on the left, right, and top and two on the underside of the tank. The data transmission rate was set to five samples per second.

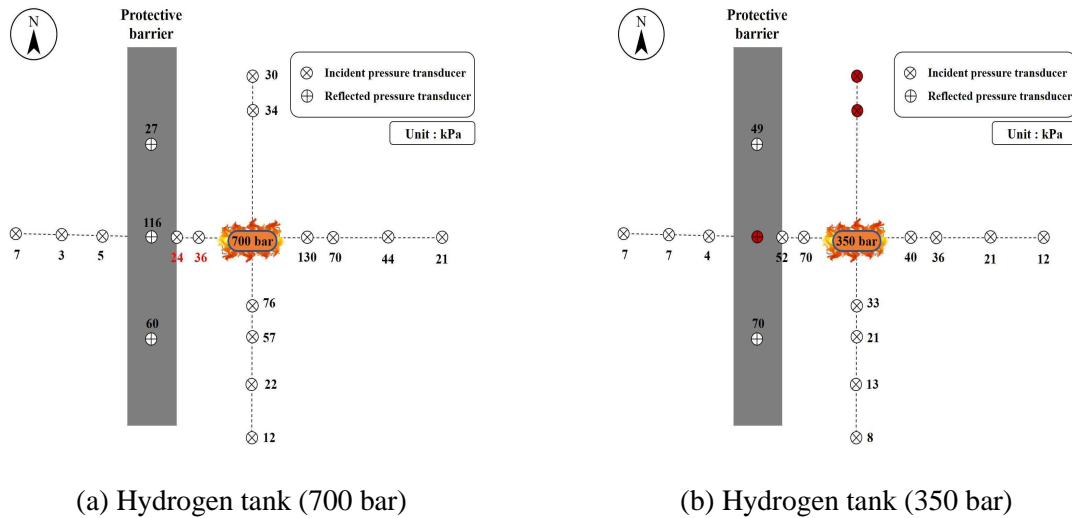
Figure 7. Values measured by the transducers at their respective positions

The maximum recorded pressures at each pressure transducer location are shown in Fig. 7. Notably, the three transducers failed to record data during the 350-bar hydrogen tank explosion test.

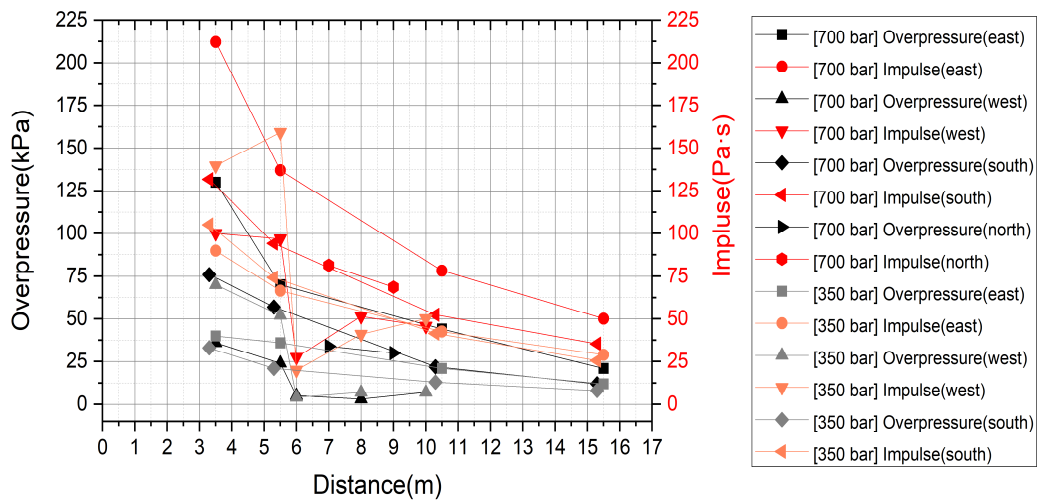
Figure 10. Peak incident and reflected overpressure and impulse as a function of distance from the tank

10 highlights the incident overpressure and impulse from each explosion as a function of distance from the tank.

The maximum peak incident overpressure and impulse measured in the 700-bar hydrogen tank during the explosion were 60 kPa and 52.92 Pa·s, which were 1.8 and 1.3 times higher, respectively, compared to those measured in the 350-bar hydrogen tank.

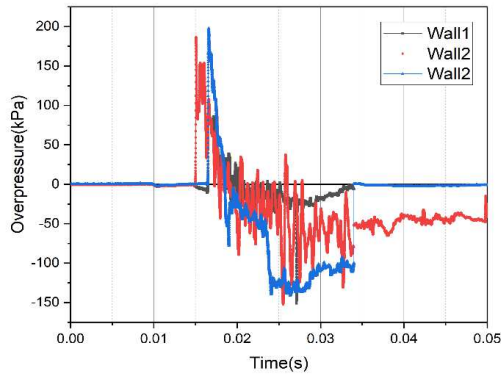
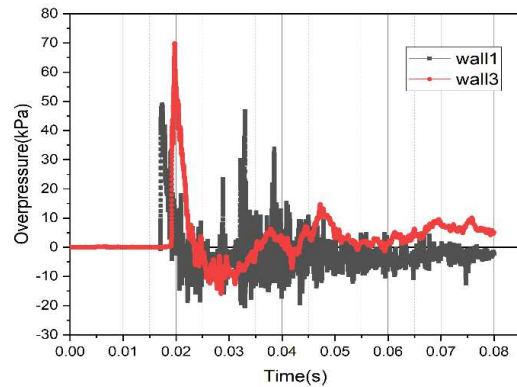
Figure 11. Reflected overpressure graphs as a function of time

The reflected overpressures, as measured at the protective barrier, are demonstrated in Fig. 11.

(a) Hydrogen tank (700 bar)

(b) Hydrogen tank (350 bar)

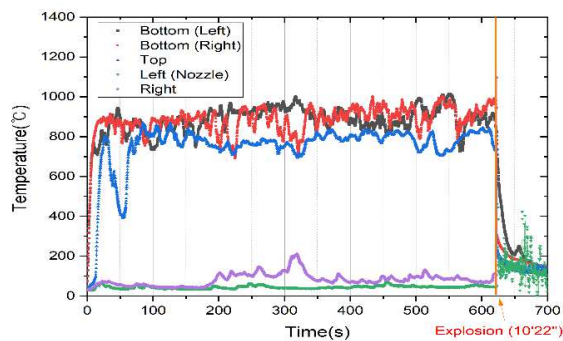
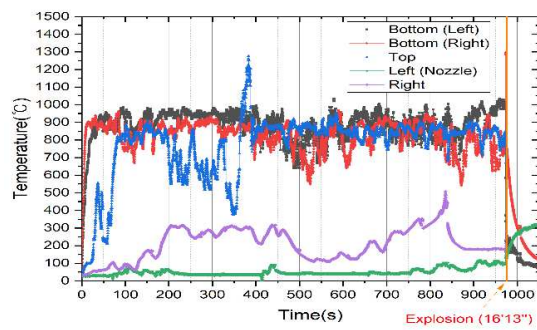
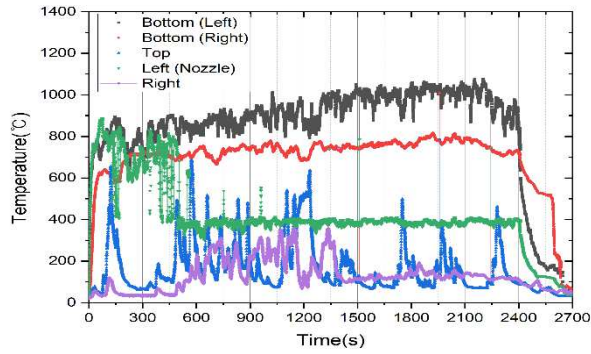
Figure 12. Temperature readings of the tank as a function of burn time

Changes in the tank temperatures over time are plotted in Fig. 12. Two thermocouples, installed on the underside of the 700-bar hydrogen tank, measured similar temperatures to each other, but consistently reported temperatures 100-200 °C higher than those reported by the thermocouple installed on the top. A thermocouple on the right (east) side of the tank consistently measured temperatures 50–100 °C higher than that on the left (west). After the heptane burner was lit for 200 s, the tank itself started to burn, and the fire spread across the tank. The temperature was measured at approximately 800–1000 °C at the bottom and top of the hydrogen tank.

The temperatures measured for the 350-bar and 700-bar hydrogen tanks test were similar. The temperatures measured at the top and the underside of the tank were also similar. However, at the top of each tank, the temperature dropped to 350 °C between 200-300 s after burner ignition and then rapidly increased to 1300 °C within the next 50 s. The right (east) side of the 350-bar hydrogen tank was approximately 100 °C higher than that in the 700-bar hydrogen tank in the same time period.

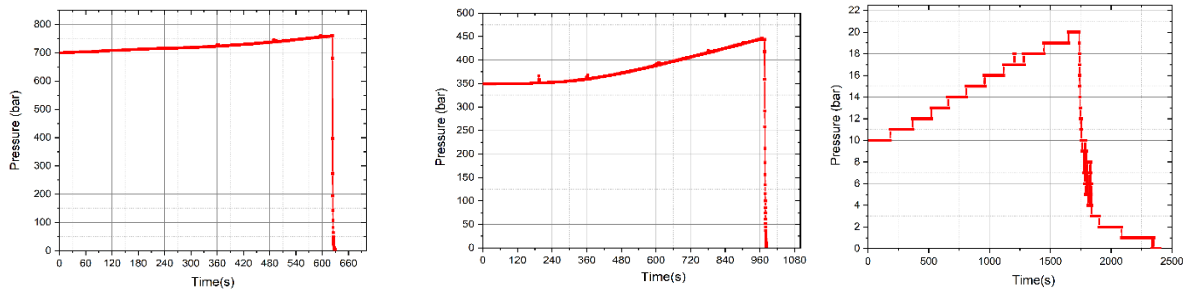
Figure 13. Internal pressure as a function of time

Changes in the internal pressure of each hydrogen tank are plotted as a function of time in Fig. 13. The data transmission rate was set to one sample every 0.25 s. The internal pressure of the 700-bar hydrogen tank increased to 760 bar in the time leading up to the explosion at 10 min, 22 s after burner ignition. The internal pressure of the 350-bar hydrogen tank increased to 446 bar in the time leading up to the explosion at 16 min, 13 s after burner ignition. The internal pressure of the 10-bar hydrogen tank increased to 20 bar approximately 29 min after burner ignition, after which the tank ruptured and the internal pressure rapidly dropped to 4 bar. Approximately 10 min were required for the remaining hydrogen gas to escape from the tank until the internal pressure finally fell to 0 bar, 40 min after burner ignition.

3) The internal pressure of the 700-bar and 350-bar hydrogen tanks rose to 760 bar and 446 bar, respectively, immediately before explosion. The 10-bar hydrogen tank did not explode, but ruptured at 20-bar after 29 minutes of burning.

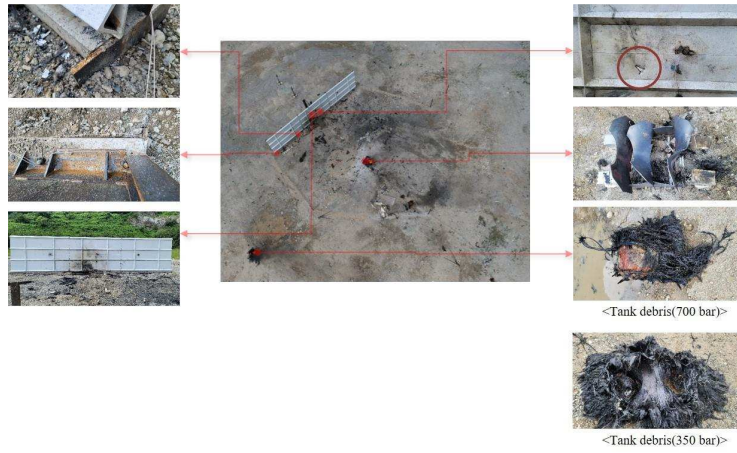
Figure 14. Distribution of fragments and debris

After each experiment, the protective barrier was examined for damage and tank fragments and debris were located, as shown in Fig. 14. The surface of the Type 4 model hydrogen tank is made of carbon fiber, which weakens when exposed to fire. During the 700-bar test, the east side of the barrier (facing the explosion) lost physical strength quickly due to the prevailing east wind and consequent debris scattering to the west. During the 350-bar test, light winds were observed, and the bottom center of the tank was the source of the primary rupture, causing debris to scatter to the south. During both explosions, blackened carbon fibers were scattered up to 10 m from the tank and the tank holder was bent. Fragments from the 700-bar test tank collided with the 4.5-mm-thick steel protective barrier, creating a 4 cm hole, and violently shook the concrete base, leaving cracks within it. The accumulated major debris of the 700-bar and 350-bar test tanks weighed 25.9 kg and 42.1 kg, respectively. Fragments weighing more than 4.5 kg, the typical weight of the head of a 70 kg man, can be lethal owing to the resulting concussion [24]. If the debris of the 700-bar hydrogen tank had scattered away from the barrier, the energy likely would have projected the is over 70 m from the initial location of the tank.

4) During the 700-bar test, the fragmented debris violently collided with the 4.5-mm-thick steel protective barrier, creating a 4 cm hole in the barrier. Additionally, the carbon fiber lining of the tank scattered up to 10 m away from the tank.

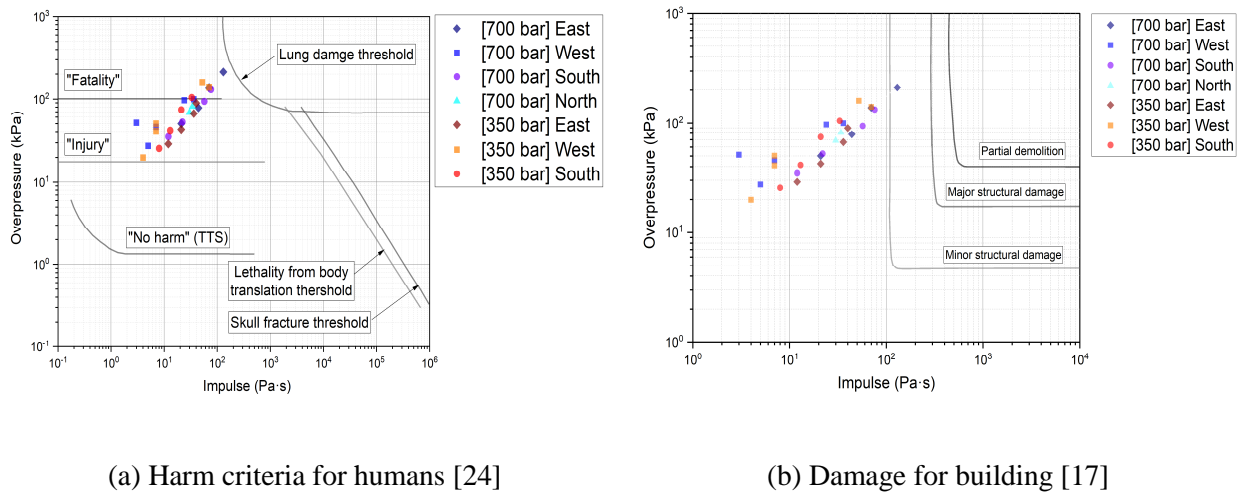
Figure 15. Overpressure-impulse thresholds

Fig. 15 plots the maximum peak overpressure and impulse values measured in this study relative to previously determined damage criteria for humans and buildings.

(a) Harm criteria for humans [24]

(b) Damage for building [17]

The human safety distance is the distance outside of which no temporary hearing loss occurs, called a temporary threshold shift (TTS) [25]. A blast wave with a magnitude of 16.5 kPa or higher can cause barotrauma of the human ear (eardrum rupture), and that of 100 kPa or higher results in life-threatening pulmonary hemorrhage [26, 24]. Based on the measured peak overpressures, there is a near certainty of eardrum rupture at 5 m from an explosion, and a high likelihood of fatality as far away as 3.5 m. Blast waves with an overpressure greater than 4 kPa and an impulse greater than 100 kPa can cause minor structural damage to buildings, such as shattered windows. Therefore, any building within approximately 5 m of a tank explosion will likely have minor damage.
