A study of decrease burst strength on Compressed-hydrogen containers by drop test

**Japan Automobile research Institute
E-mobility Research Division**

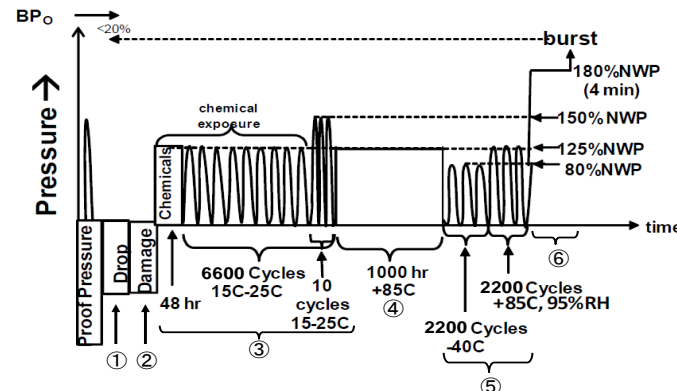
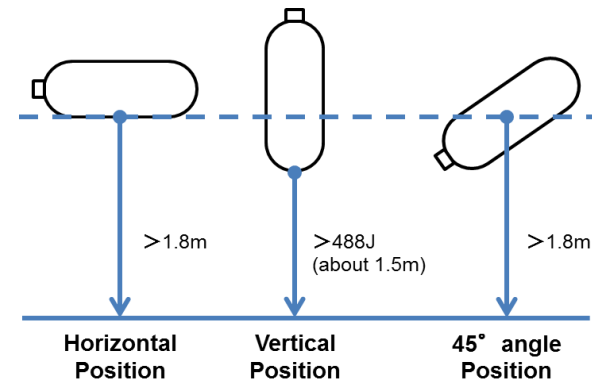
- The residual burst pressure at the End-of-Life decreased by about 5% from the initial burst pressure.
- The variations of the residual burst pressure at the End-of-Life were increased from the initial.
- An impact site during vertical drop test may become the initial rupture point.

→ It seems to be affected by drop test that directly damages the dome part.

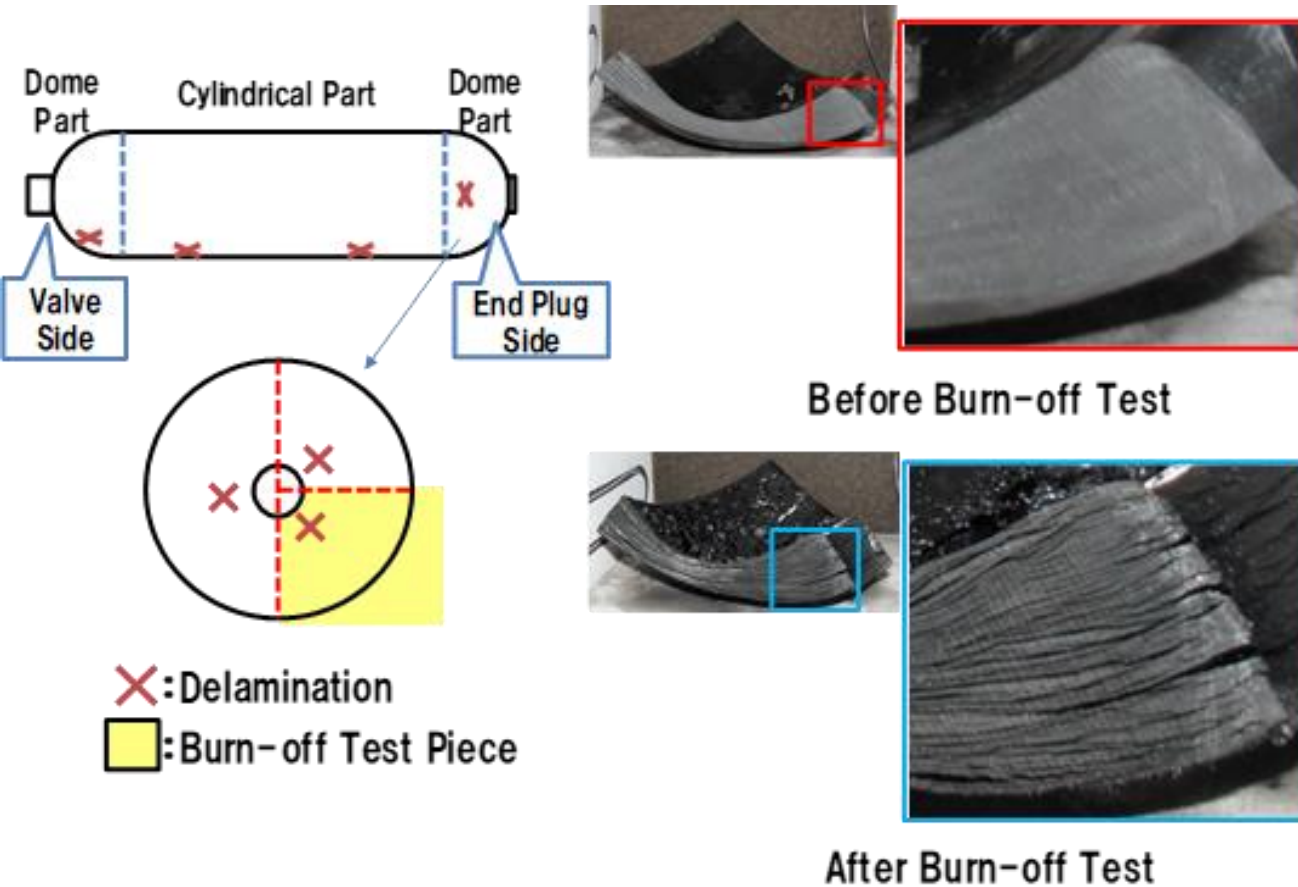
- ◆ The ultrasonic test and X-ray CT imaging **cannot observe carbon fiber breakage.**
- ◆ We conducted a burn-off test to examine the degree of carbon fiber damage within the CFRP layer.

- ◆ No carbon fiber damage was observed in this test piece.
- ◆ CFRP damage during the vertical drop test was confined to delamination, with no damage to the carbon fibers

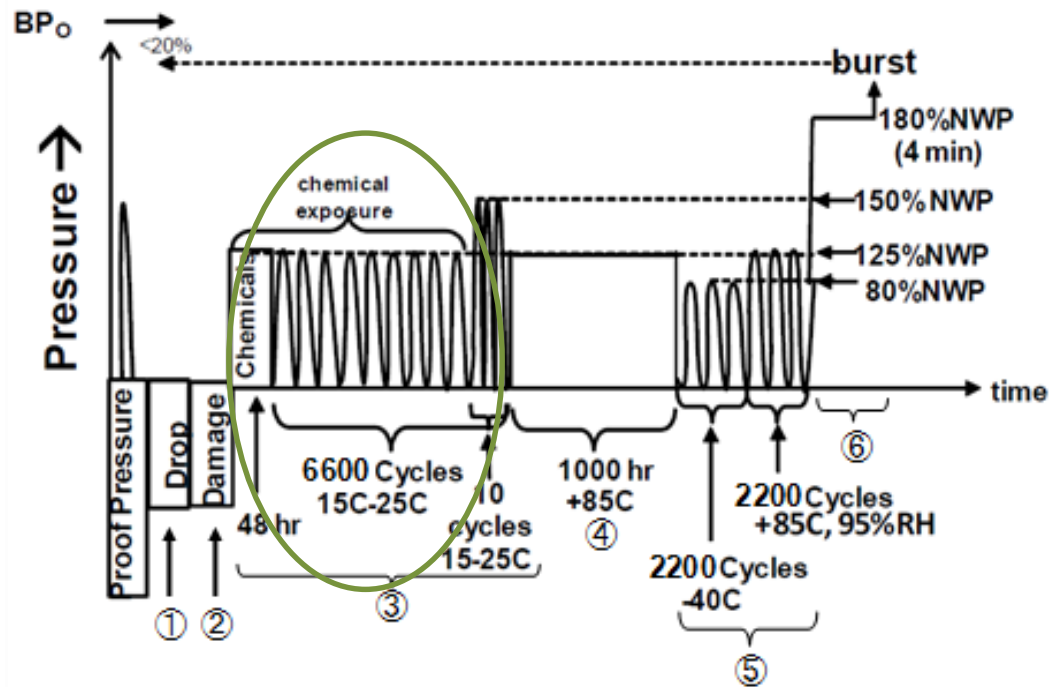
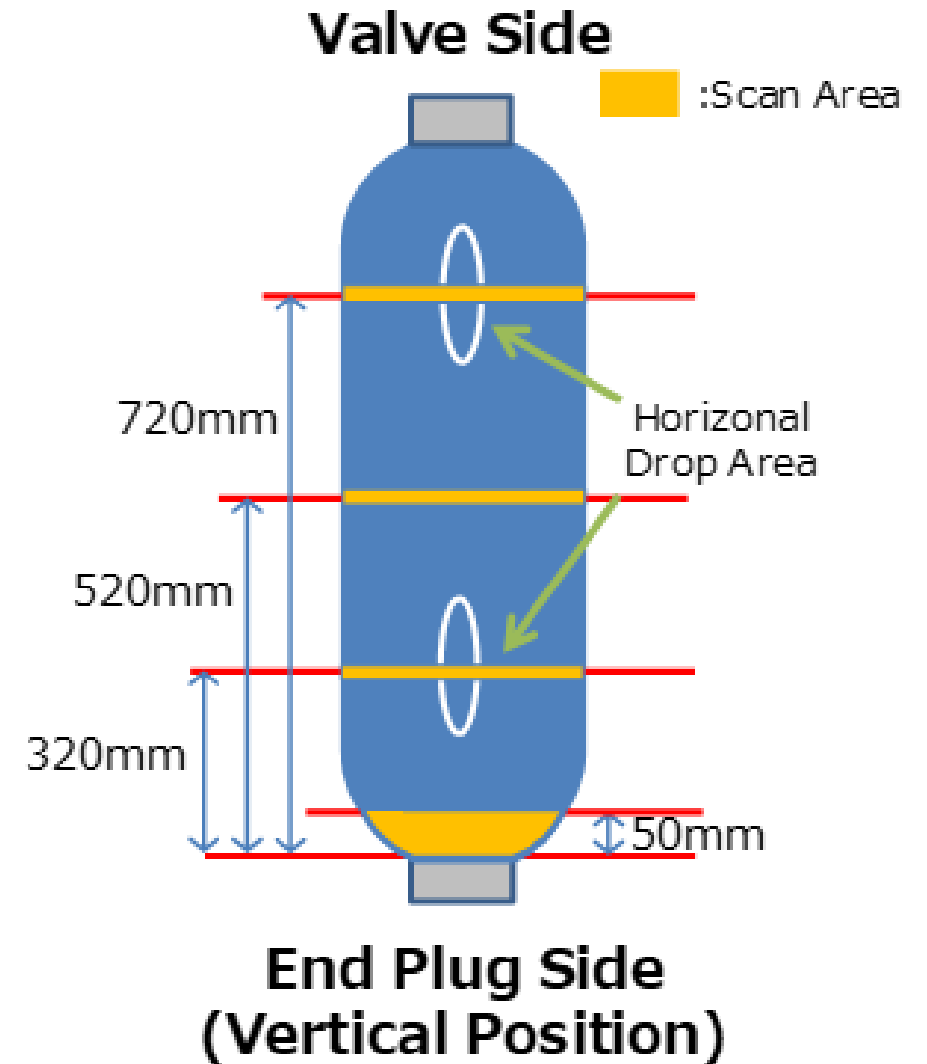
- ◆ Pressure cycling test after the drop test may **distort the container**, thus possibly **propagating delamination**.
- ◆ X-ray CT imaging was performed on the container after the pressure cycling test to investigate the influence of the pressure cycling on the delamination.

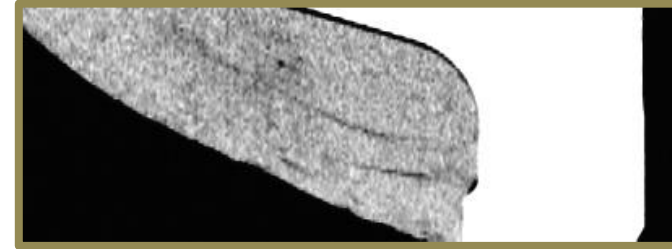
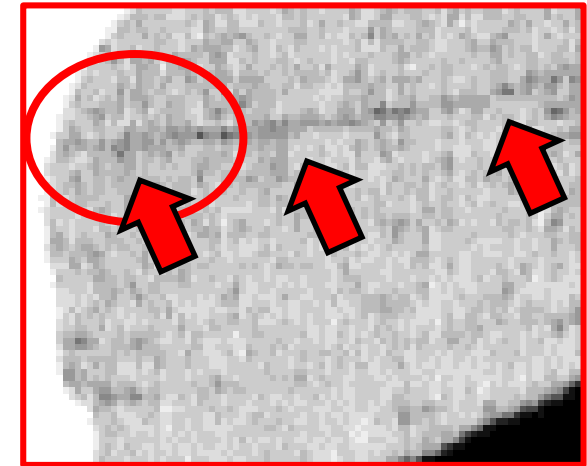
2. Some of the developed delamination extended to the boss.

→ This finding suggests that the load sharing of the CFRP layer due to the delamination displacement fluctuates, thus decreasing the burst strength of the dome part.

Delamination propagation during the pressure cycling test may be the primary factor that contributes to the decrease in the burst strength of the dome part.

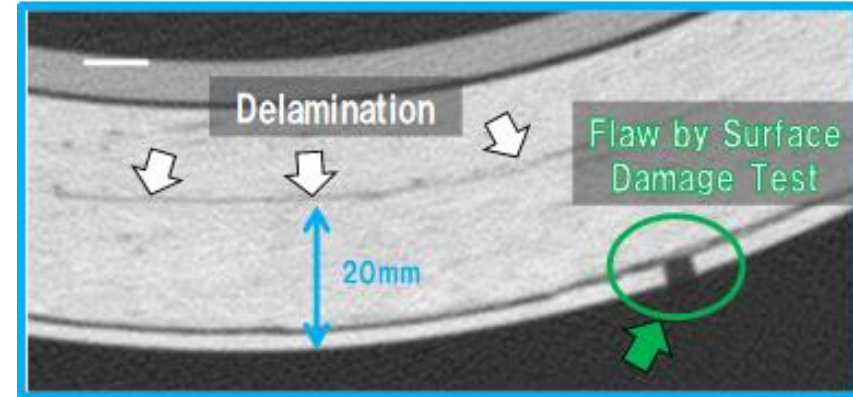
◆ Cylindrical Part

1. Delamination has occurred by drop test.
2. The change in the delamination gap in the cylindrical part is unclear due to the lack of CT images before and after the pressure cycling test for comparison.
3. The cylindrical part is in a stable plane stress state that is parallel to the delamination.
→ **Delamination does not propagate as easily as the dome part**
4. The damage due to the **surface damage test** becomes the **dominant factor** in the decreased strength of the cylindrical part because the carbon fiber that is responsible for most of the CFRP strength is divided in the cylindrical part.

The damage to the cylindrical part via the drop test is expected to have little effect on burst strength
