A STUDY OF DECREASE BURST STRENGTH ON COMPRESSED-HYDROGEN CONTAINERS BY DROP TEST

Masuda, S.¹, Tomioka, J.², Tamura, H.³ and Tamura, Y.⁴

¹ E-mobility Research Division, Japan Automobile Research Institute, 1328-23, Osaka, Shirosato, Ibaraki, 311-4316, Japan, mshun@jari.or.jp

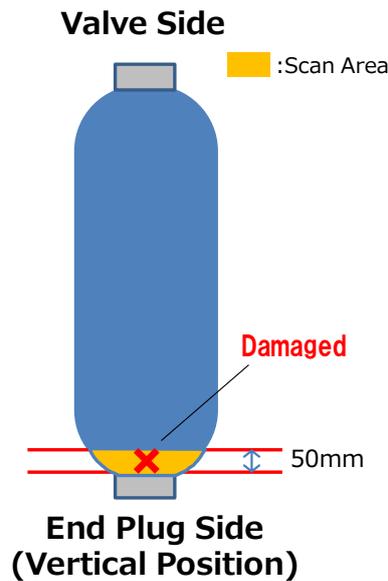
Figure 7. CT scan area

The ultrasonic test results clearly indicate that the drop test damaged the CFRP layer. The damage is considered delamination within the CFRP layer because it is parallel to the container surface [6]. However, a conclusive interpretation cannot be made using only the ultrasonic flaw test results. Therefore, X-ray CT imaging was performed to investigate the damage at the dome part of the containers in more detail. Figure 7 shows the scanning area. The area that extends 50 mm from the CFRP end of the plug side at the dome part of the container was scanned at 0.5 mm intervals in a circular fashion. Furthermore, image analysis software was used to combine the captured images and create a composite 3D image. We investigated the degree of CFRP delamination at the dome part of the container with this composite image. The cross sections of the CT image locations were also compared to the intact condition.

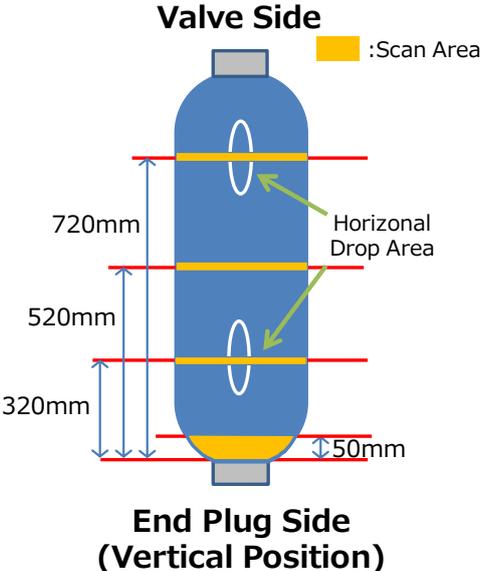
Figure 13. CT scan area (after pressure cycling test)

The ultrasonic flaw detection test and X-ray CT imaging results revealed that the drop test generated delamination in the CFRP layer. However, subsequent pressure cycling test may distort the container, thus possibly propagating delamination. Therefore, X-ray CT imaging was performed on the container after the pressure cycling test to investigate the influence of the pressure cycling on the delamination. The imaging method is the same as that in Section 3.2, with the scan areas up to 50 mm from the plug side at the dome part; the 320 and 720 mm from the plug side, which are the landing sites from the horizontal drop test; and the 520 mm from the plug side, which is the intermediate area (Figure 13).
