## Hydrogen related accidents and lesson learned from events reported in the in east continental Asia

### Abstract

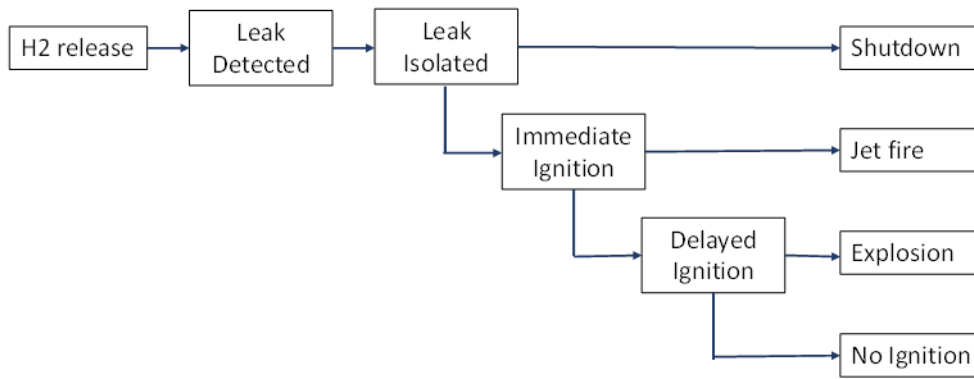
The figure 12 below shows the event consequence after a hydrogen leak, if the leaked hydrogen can be detected and isolated, it will not lead to damage. Otherwise, immediate ignition leads to jet fire, delayed ignition will cause explosion, respectively. If a leak cannot be detected, there is a possibility of a jet fire, explosion or non-ignition. Table 1 shows the percentage of accidents linked to delayed ignition and immediately ignition from "Major Hazard Incident Database Service of the Health and Safety Executive (UK)" [3] and the study of this paper. UK database shows 95% immediate ignition, the statistical data from accidents in this study shows only 60%. The results from later study show the more potential to take safety measures to react to the delayed ignition.

Figure 12: event consequence after a hydrogen leak [4]

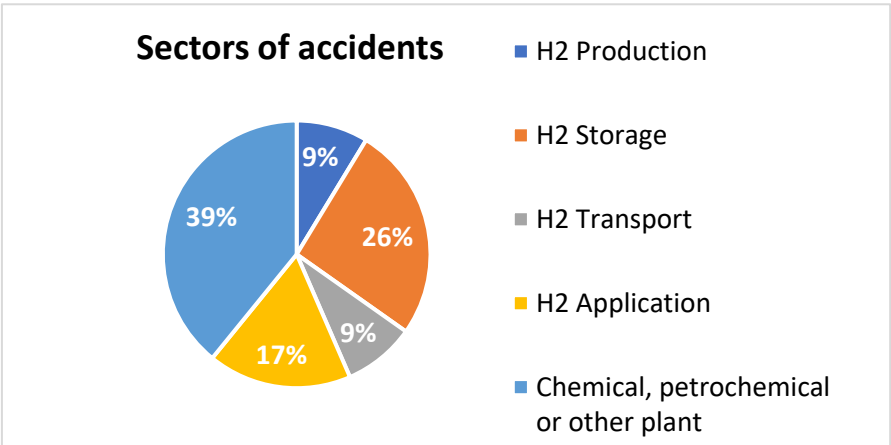
Some criteria from [2] are used to evaluate the accidents, such as sectors in the hydrogen value chain, root causes, severity of human damages; in addition, the cause of ignitions is put into the focus. Figure 13 shows the industrial sector in which the accidents are distributed, and most of them are in the chemical and petrochemical sector. From Figure 13, 26% of accidents are related to the storage of hydrogen, i.e. to the high pressure storage of hydrogen. This shows the importance of high-pressure hydrogen storage and its risks. It is worth noting that 17% of the accidents that occurred during the application of hydrogen, of which 3 involved air balloons, indicated the importance of managing the safety of the application of hydrogen when dealing with people who may lack expertise in hydrogen safety.

Figure 13: Accidents occurred in different industrial sectors

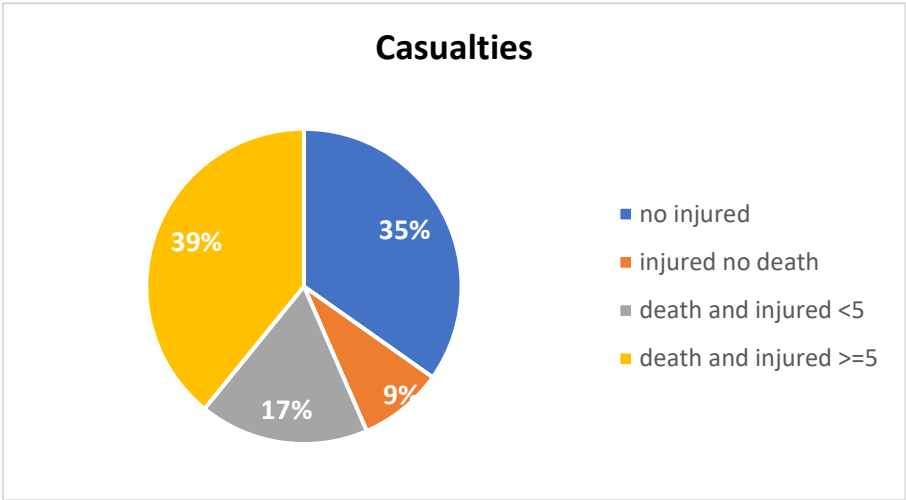
Casualties caused by accidents are shown in Figure 14, there were 35% of accidents with more than four fatalities and 35% of accidents with no fatalities, and it is worth noting that 35% of accidents still resulted in no injuries.

Figure 14: Casualties caused by accidents

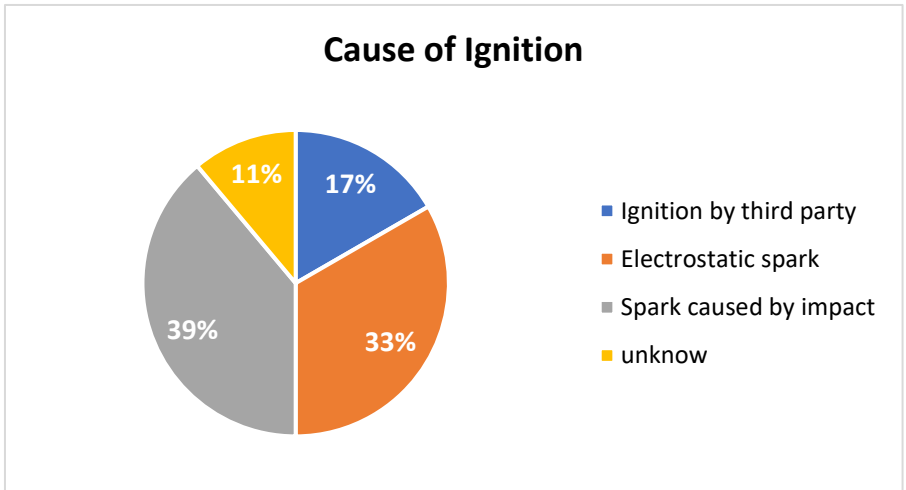
Figure 15 shows that the causes of fires from sparks due to impact, sparks due to friction and electric sparks exceed 70%, confirming the drawbacks of hydrogen as an energy carrier in terms of safety having a very small ignition energy, therefore being very prone to accidents.

Figure 15: Cause of Ignition

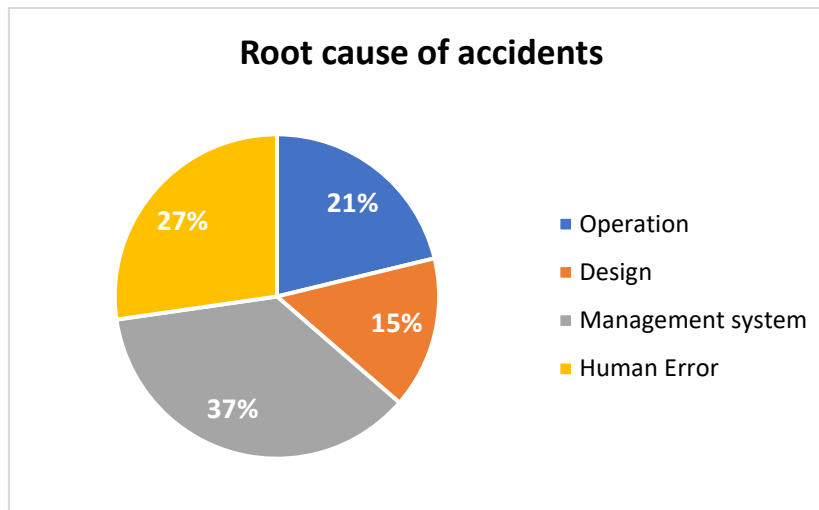
Finally, Figure 16 shows the causes of accidents, with up to 37% of accidents being related to management. Theoretically, accidents that occur are directly and indirectly related to safety management. Therefore, it is important to strengthen the management of hydrogen safety.

*Figure 16: Root cause of accidents*
