Statistics, lessons learnt and recommendations from analysis of HIAD 2.0 database

Abstract

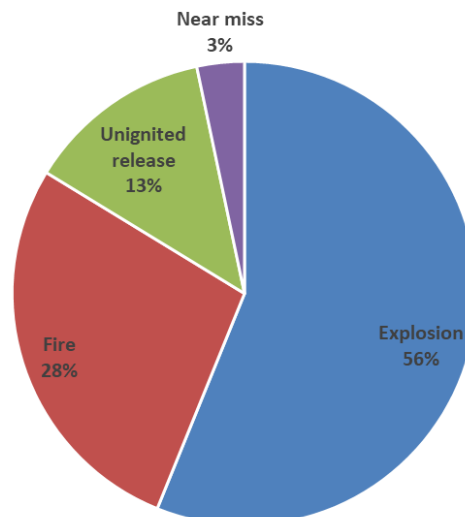
Figure 3: Consequences of the reported incidents.

It is widely known that hydrogen has a wide flammability range (4-76 %), requires little energy to ignite and reaches relatively high laminar flame speeds. Accidentally released hydrogen is prone to be ignited in the presence of an ignition source. Among the 426 incidents considered, apart from the 3 % near misses and 13 % un-ignited releases, hydrogen was ignited in 84% of the incidents with 56 % involved explosions and 28 % of the incidents resulted in only hydrogen fires . The 13 % incidents without ignition were attributed to a number of reasons, e.g. the unintended releases being promptly stopped. several incidents in this category just released relatively little hydrogen, etc. The 3 % near misses indicates that early detection and prompt action to mitigate any potential releases can still successfully avoid major hydrogen releases.
